U.S. CHEMICAL SAFETY AND HAZARD INVESTIGATION BOARD

OIL REFINERY FIRE AND EXPLOSION

No. 2004-08-I-NM
October 2005

GIANT INDUSTRIES' CINIZA OIL REFINERY

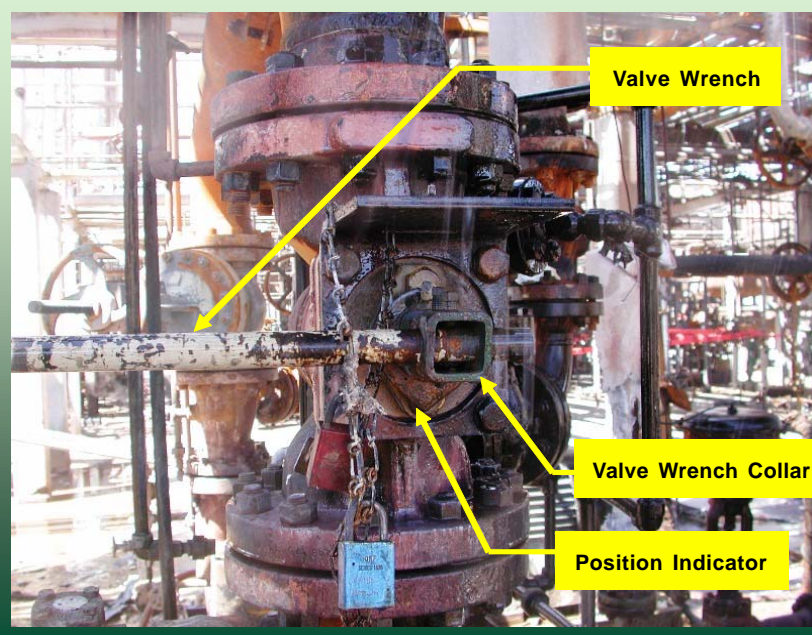
Figure 1.

the closed position with the wrench perpendicular to the flow of product. Interviews with several operators revealed that some operators used the valve wrench's position relative to the flow to determine whether the valve was open or closed, while others referred to the position indicator on the valve stem. The valve was actually open.

The pump needed to be disassembled and the rear pump housing assembly and impeller moved to the shop for repair. Before leaving the area to obtain materials needed to remove the pump, the mechanic noticed that the valve position indicator on the suction valve body showed that the valve was open (See Figure 1). He did not relate this information to his co-workers.

Suction Valve and Position Indicator as Found After Incident

Neither mechanic observed the operator closing the valve. Both mechanics believed the task had been completed because the wrench used to open and close the valve was positioned perpendicular to the flow, and the operator had affixed his tags. (See Figure 1)

Any valve position indication used by employees to determine the open/closed position of valves should communicate accurate information to employees. Valve modification should receive MOC analysis to determine whether new hazards or risks have been introduced.

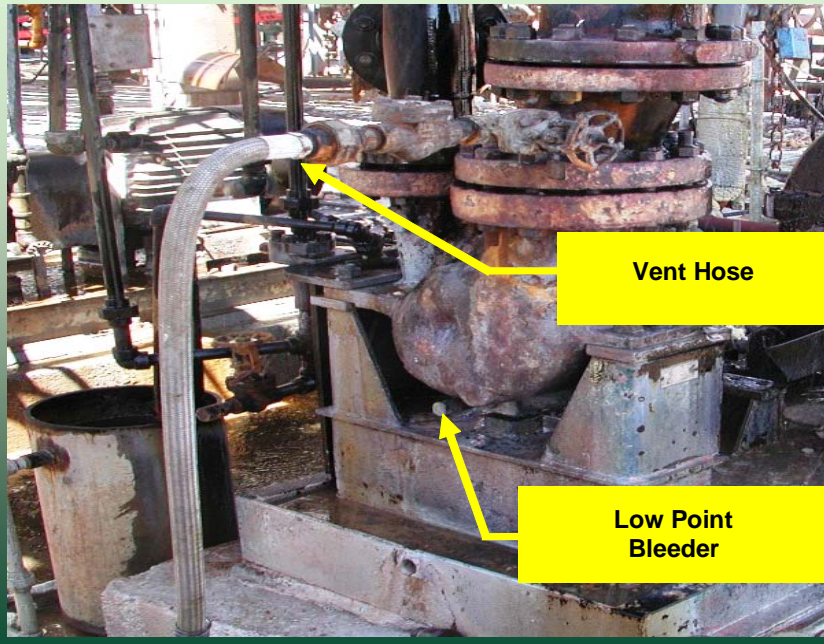
Figure 2

Depressurizing Hose

The operator then disconnected the pump's vent hose to verify that no pressure was in the pump case. The low point drain plug was not used because it was not equipped with a valve to isolate it from the line used for depressurizing the pump. (See Figure 2) Giant lockout/tagout procedures outlining operator responsibilities state:

After uncoupling the hose at the connection to the flare line, a stream of alkylate flowed from the pump housing through the hose and subsided after a few seconds. The operator and the maintenance mechanics believed the pump had been de-pressured and was ready for removal. Actually, the vent line was plugged, and the pump was not de-pressured.

Lockout/tagout programs should require effective verification that equipment has been isolated, depressurized and drained.

locked out, the facility lacked procedures to verify that the pump had been isolated, depressurized and drained. Equipment being prepared for maintenance should be drained of all liquid at a low point drain.

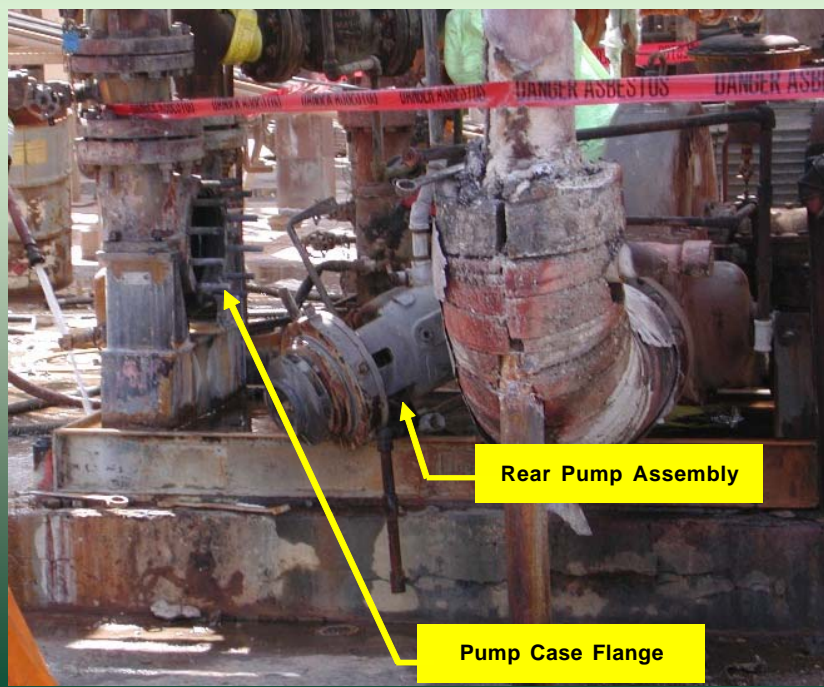
Figure 3.

Damage to Area of Pump

The pump shaft coupling and the flange connecting the pump to the pump case were unbolted. (See Figure 3) As the pump case flange was separated, alkylate was suddenly released at about 150 pounds per square inch gauge (psig) and 350 degrees Fahrenheit. The release produced a loud roaring sound that could be heard throughout the refinery.

The mechanic was blown over an adjacent pump and suffered broken ribs. Material was blown into the mechanic specialist's eyes so he made his way to an eyewash station, cleared his eyes, and then quickly exited the unit. Alkylate, which covered the plant operator's clothing, quickly ignited, seriously burning the operator in the ensuing fire. About 30 to 45 seconds after the initial release, the first of several explosions occurred.

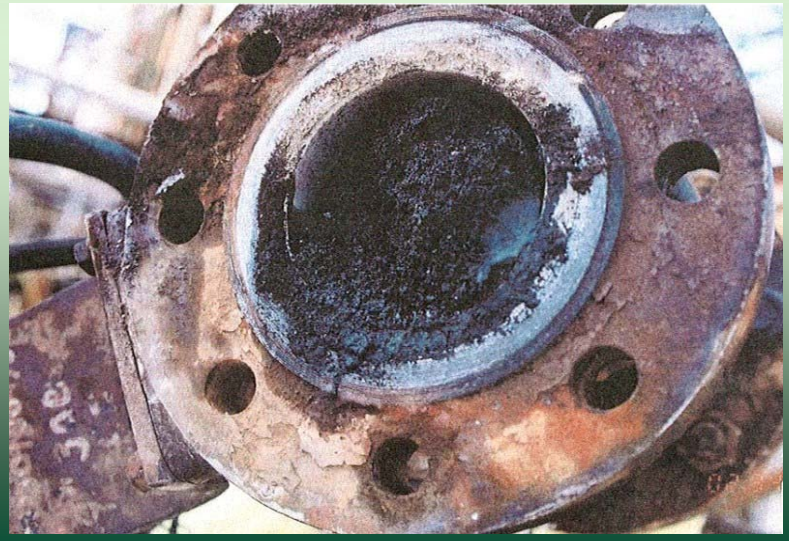
Figure 4

Giant's mechanical integrity program did not effectively prevent these repeated failures of the pump seals. After the incident occurred, plugging material was found in the pump discharge line, the depressurizing line, pump housing, and the impeller. (See Figure 4). Giant's approach to these frequent pump seal problems was an example of breakdown maintenance. In other words, pump failures were addressed when the equipment finally broke down, instead of identifying causes of breakdowns and preventing them before they occurred again.

cleanup activities. Some of this soft, water-laden scale comes off when the unit is running. The rest creates a site for extremely fast and extensive corrosion, resulting in a large amount of scale being added into the process. Scale may accumulate and settle at low points and orifices in equipment such as spare pumps.

Giant management did not investigate why excessive iron fluoride generation in the process caused the mechanical seals on the alkylate recirculation pumps to fail repeatedly.

Plugging Material Found in Discharge Valve

Mechanical integrity programs should prevent breakdown maintenance. Identifying operating conditions that could be contributing to equipment failure is a critical component of mechanical integrity.

Instead of determining the cause of frequent pump malfunctions and then implementing a program that would prevent problems before they occurred, Giant used breakdown maintenance by making repeated repairs to the pump seals after failure.

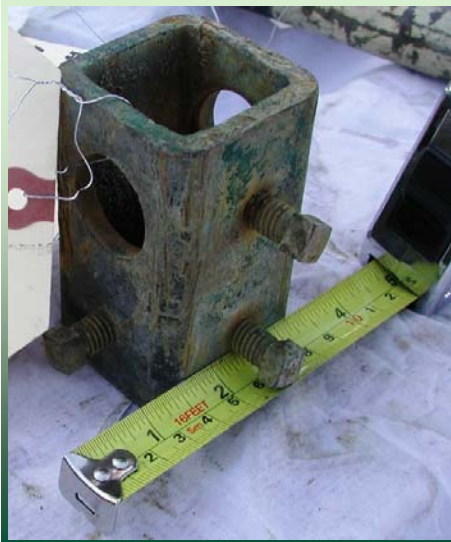
Figure 5

Examination of the 6-inch, ¼ turn, plug valve after the incident determined that it was originally designed to be opened and closed by a gear-operated actuator. The gear-driver had been removed and was replaced by a valve wrench. The wrench was a two-foot-long bar inserted into a collar. Because it had a square shape, the collar could be easily removed and repositioned on the valve stem in different directions. (See Figure 5)

Giant did not consider the design or engineering safety implications of changing from a gear-operated valve actuator to using a wrench as a valve handle.

Spare Pump Valve Wrench Collar

In some instances, set screws would be loosened, and the wrench would be removed and placed on the pump base to provide better clearance for personnel walking nearby. When the valve was to be opened or closed, the wrench would be replaced on the valve stem. In the Ciniza oil refinery incident, the valve wrench collar was installed in the wrong position.

Although the valve had a position indicator, employee practice was to sometimes use the position of the valve wrench to determine the open/closed status of the valve. The valve collar and wrench were not permanently fixed to the stem and were positioned incorrectly. When the valve was changed from a wheel and gear-driven mechanism to a wrench, the collar could be attached in the wrong position. An MOC hazard analysis was not conducted. If an MOC had been used, it could have revealed the potential for the valve wrench to be oriented in the wrong direction.

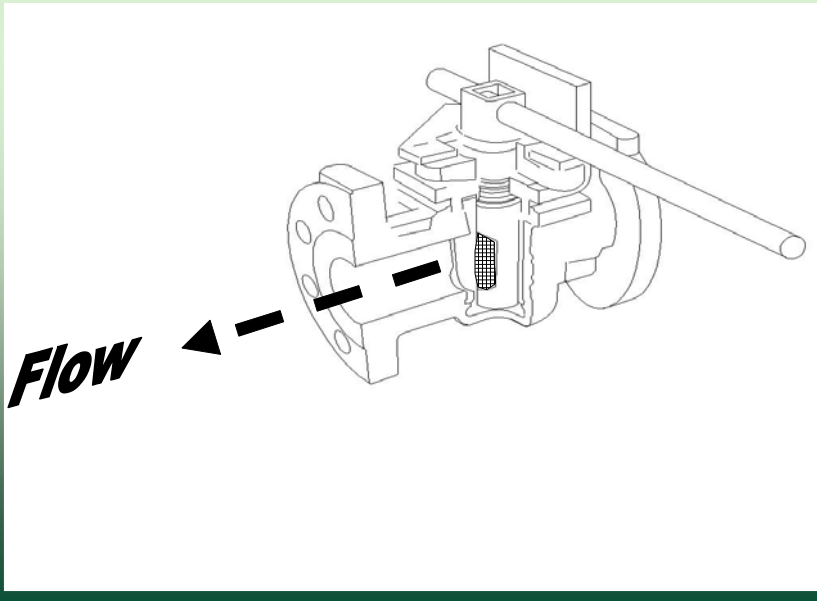
Plug Valve in the Open Position

Figure 6 is a drawing of the plug valve in the open position with the wrench in the perpendicular or perceived “closed” position.

Both the plant operator who attached the locks and the mechanics who removed the pump mistakenly believed the suction valve had been closed, in part because the valve wrench was perpendicular to the normal pipe flow. After he returned from obtaining materials needed for pump removal, the mechanic who earlier observed the position indicator in the open position began working on the opposite side of the pump, so he did not realize the valve position indicator still indicated the valve was open. From his vantage point, he observed the valve wrench in a perpendicular orientation and believed the valve was closed.

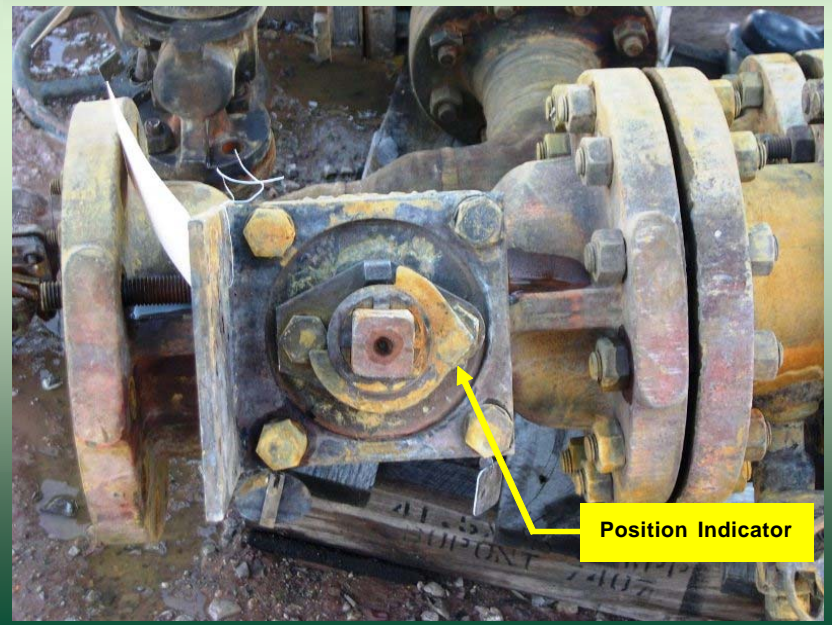
Figure 7

Technically, the wrench was not intended to indicate valve position because the valve was equipped with the position indicator, which was located on the valve stem. (See Figure 7) In practice, however, some plant employees used the wrench to determine valve position, partly because the wrench was much more visible than the actual valve position indicator.

Suction Valve & Position Indicator
