Failure Analysis: Petrochemical Plant 185 KW Cooling Tower Fan Gearboxes Year 2010

By Abdulrahman Alkhwaiter

Introduction

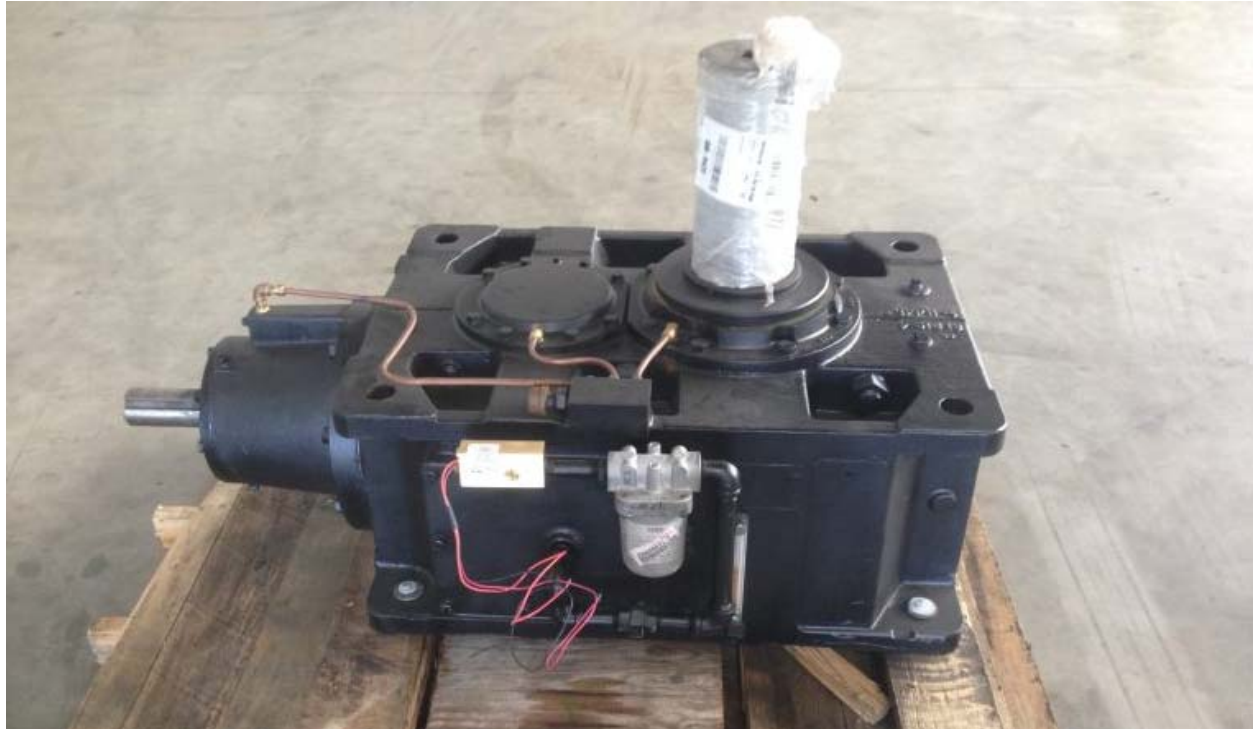
1. No signs of lube oil contamination were found on any of the three units we surveyed. All gears and bearing races were found to be shining and free of corrosion at disassembly. Oil in all units found at proper level, with few particulates, acceptable color and viscosity as per OEM. There were no signs of oil starvation or scuffing on the loaded bearing races or gear teeth. Lubrication failure is ruled out.

2. Gearboxes had correct fit of both coupling hubs on input and output shafts. No looseness.
3. The fan hub to shaft hub carbon steel coated disk is corroding severely on the bolt flange holes' location and will not operate for more than one year without repair.

4. On all units the small roller thrust bearing on top of intermediate shaft is found heavily damaged. **Failure Analysis Error: In 2010 we thought it is not a design defect but OEM said the bearing is weak and changed it to a heavy duty Bronze thrust bushing in 2011.**

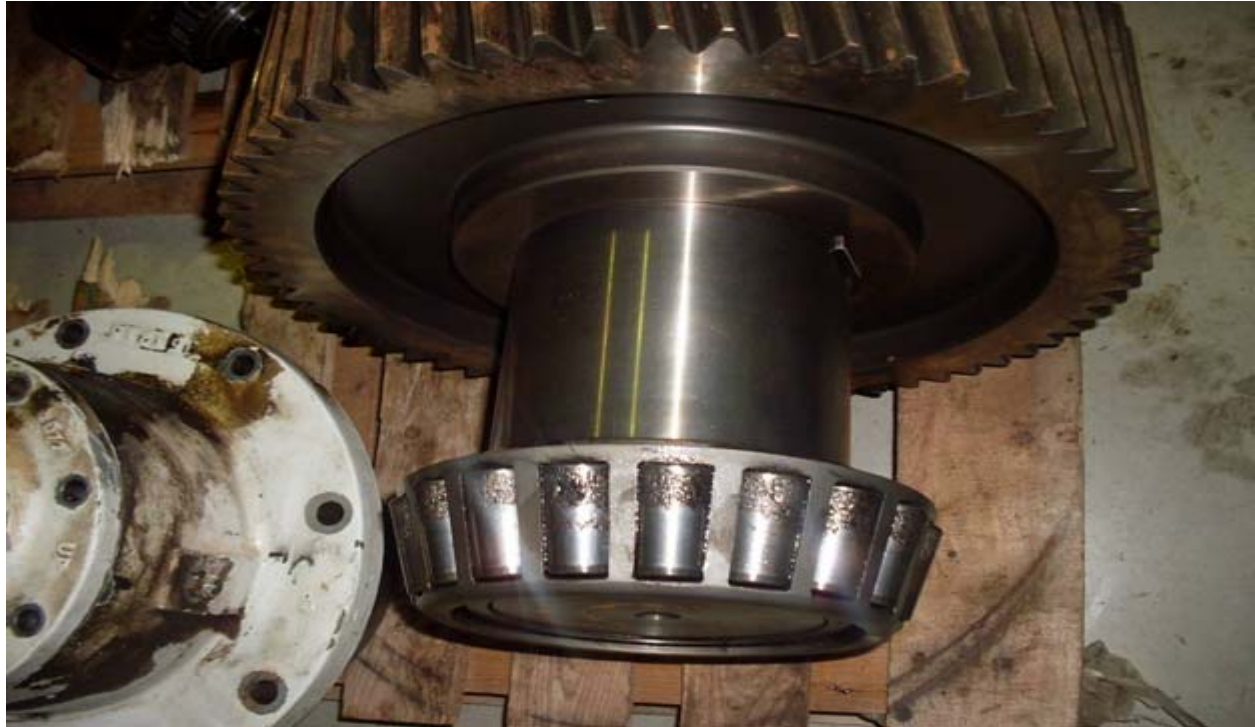
7. There is no sign of tooth breakage or teeth root fatigue on any gears, only overloading damage on tooth surface of pinion and intermediate spiral helical gears. Gear manufacturing and metallurgical quality is high.
8. The LS shaft bottom bearing on one unit has damaged, flaking tapered roller bearings (not the race) at the upper portion. This is considered a result of axial overload from excessive preloading by shims at factory.
9. The intermediate shaft on two units has both the upper and lower main spherical roller bearings damaged with surface fatigue on rollers. Again, the root cause is incorrect preloading at factory.

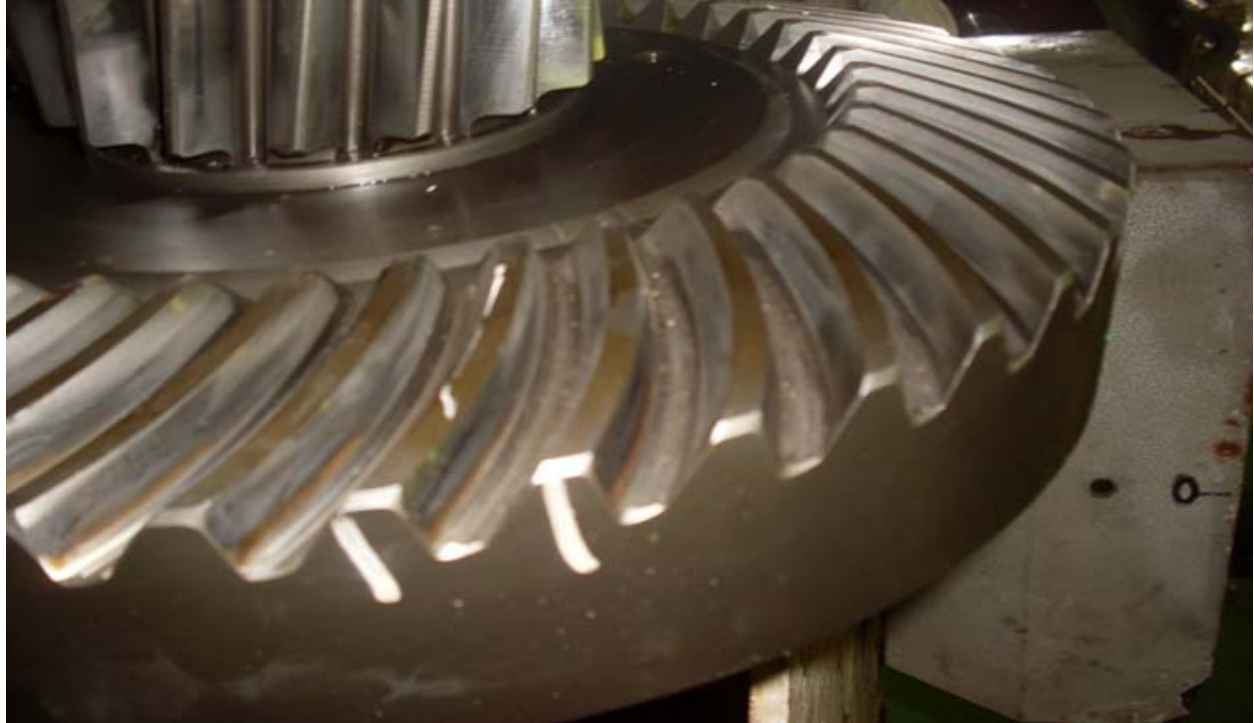
5. On all units, the pinion gear teeth are worn out and damaged with only 50 to 60% maximum contact with mating spiral helical gear. This is due to incorrect assembly at factory as all gears should have about 80% tooth contact pattern. This led to overloading of teeth and surface fatigue damage.

Intermediate Shaft: Notice Contact Pattern of 50 to 60%

1. **The intermediate gear-shaft height was set too low at factory on the three failed units**, with incorrect lower bearing housing shim thickness. By this error the helical spiral gear low position does not allow penetration of the pinion gear toward gear center to achieve desired 80% contact pattern. This resulted in overloading of pinion teeth and failure in service. The assembly workers at factory installed the pinions with axial shims to the correct backlash, but this step was incorrect as the intermediate shaft must be set at exact height first by shimming. Next the top bearing housing cover is bolted down. Then a gear contact paste or blue contact paste such as Prussian Blue is placed on spiral gear teeth to test and confirm minimum 80% contact pattern with pinion. Finally, the pinion axial shims are applied to achieve correct OEM backlash figures. It is possible that the specified OEM design preload setting is incorrect, but we do not have these figures.

1. Assemble all overhauled gearboxes using the correct assembly procedures explained above. All gears must be blue contact tested for minimum 80% contact during assembly by QA technician. QA shall also witness and record lead wire crush preload measurements on shaft bearing top covers. **Recommendation was accepted by gearbox manufacturer.**

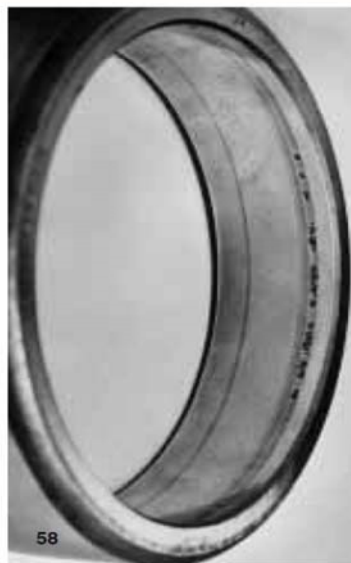
Incorrect mounting, which results in axial loading, e.g. excessive preloading of angular contact ball bearings and taper roller bearings.

Fig 58 Outer ring of a self-aligning ball bearing subjected to excessive axial loading. Flaking in the load zone

Check adjustment when mounting the bearings.

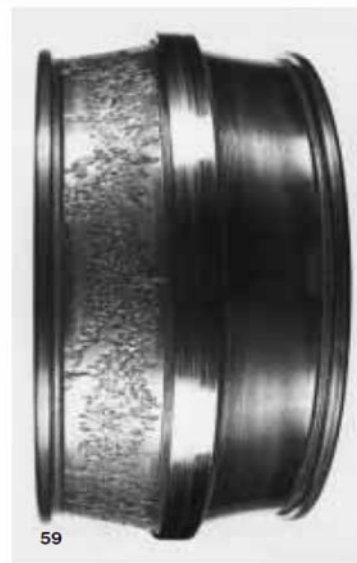
Fig 59 Flaked inner ring of a spherical roller bearing. The extent of the flaking around one entire raceway indicates that the axial load has been very heavy in relation to the radial load

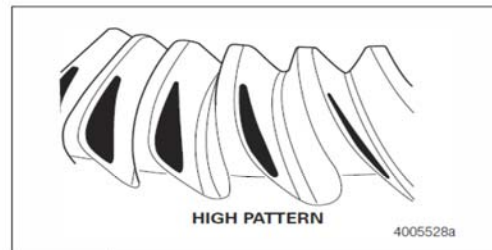
Figure 5.42

The input shaft spiral helical pinion and gear were found to have a contact pattern in the 55% to 60% range only on the three gearboxes opened. Contact found as “High Pattern”, Figure 5.42.

A high-contact pattern indicates that the drive pinion was not installed deep enough into the carrier. A low-contact pattern indicates that the drive pinion was installed too deep in the carrier.

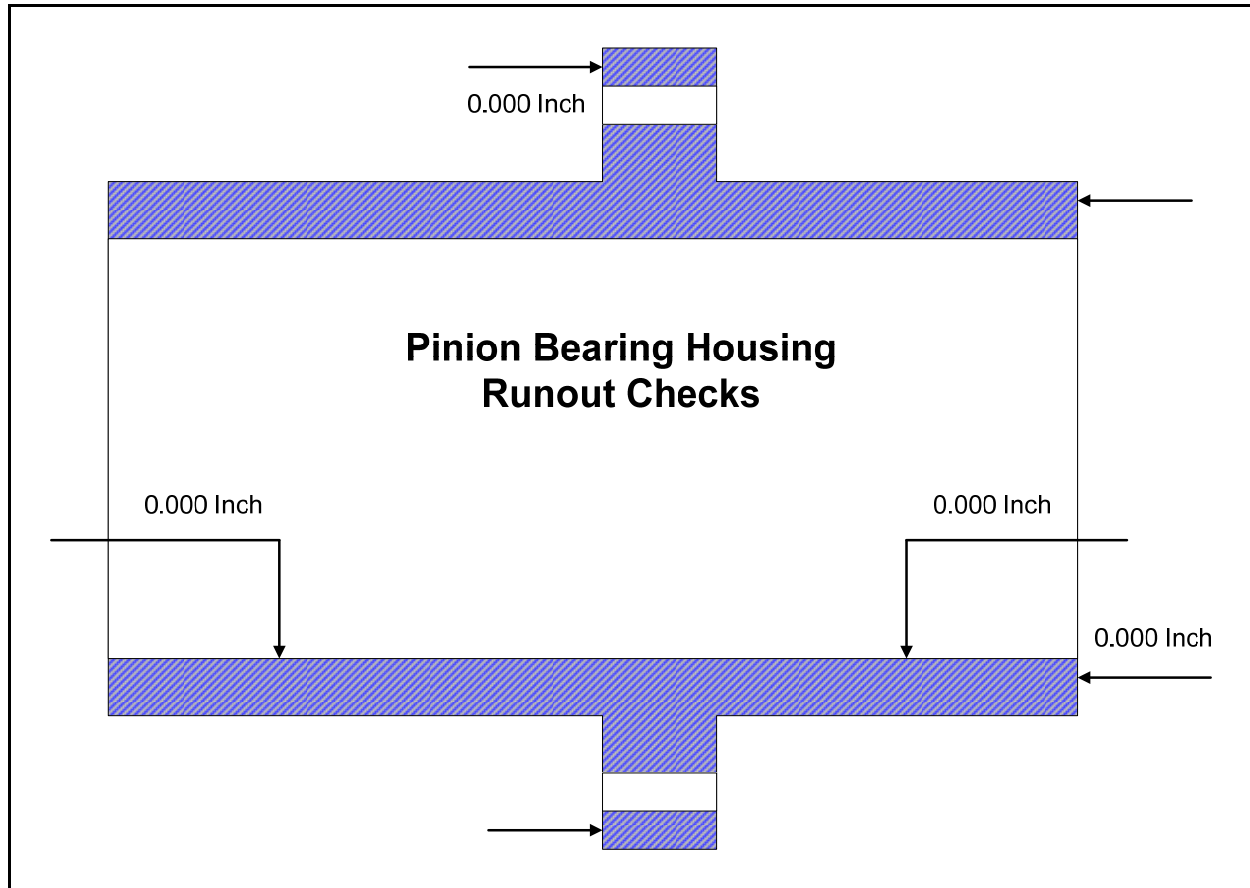
No machining errors found
