High Vibration Failure: H2 Recycle 14,000 HP 9000 RPM Centrifugal Compressor Innovative Repair

By Abdulrahman Alkhowaiter

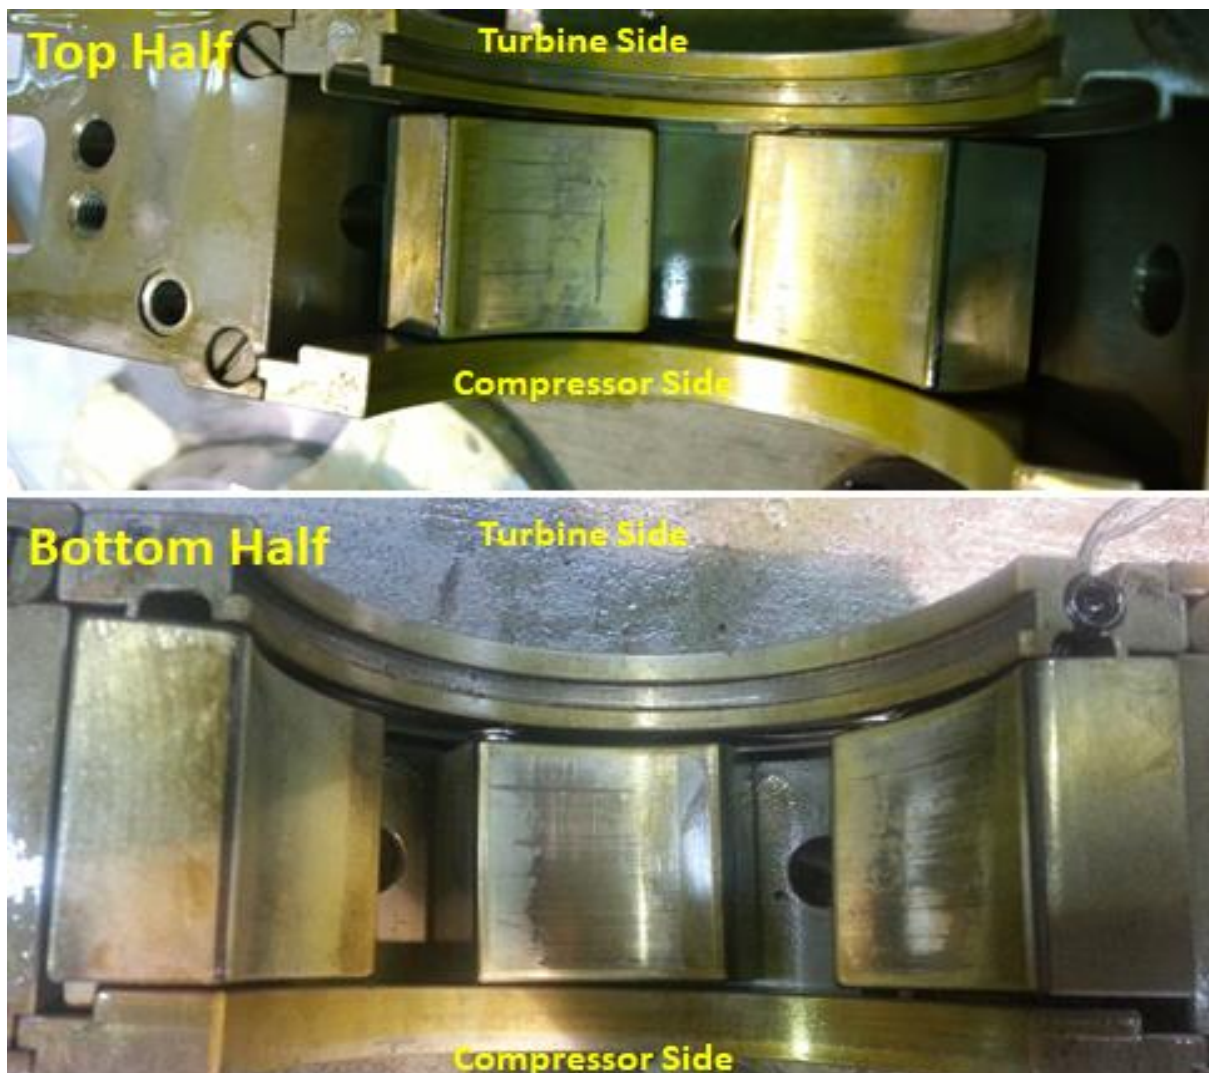
1. **Foreign Object found** in second stage impeller was causing very high unbalance. It was a heavy wire mesh, of about 80-gram weight, broken off from the suction piping strainer.
2. **Radial Drive-End bearing had fretted pads** under shaft due to the high vibration over several months, but this is a secondary damage which amplifies vibration more.

Drive End Compressor Radial Bearings: Fretting Wear Under the Lower Pads

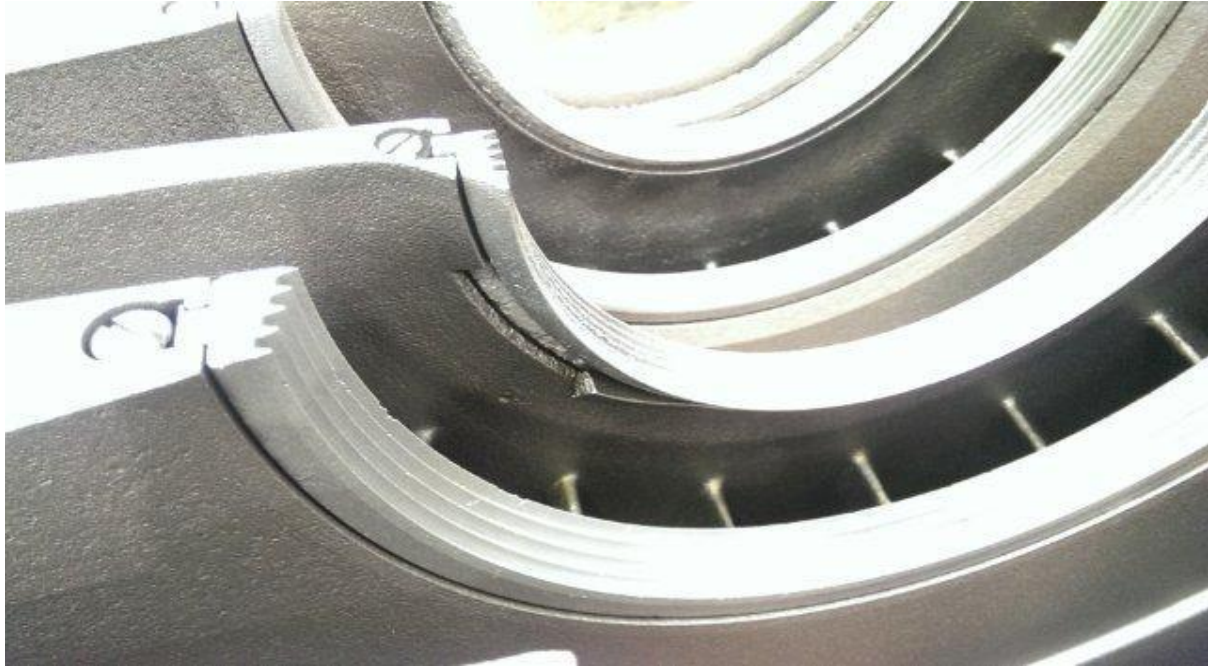
During overhaul at the repair shop the compressor cast iron diaphragm labyrinths were found to have severe damage due to liquid erosion and cracks from high turbulence vibration. No spare bundle was available. The failed components were non-weldable; this meant that the refinery must wait 3 months for new castings with USD 2.00 Million per day.

Damaged Cracked Diaphragm Labyrinth Holders; Cast Iron Not Safely Repairable

An innovation repair was proposed: New Labyrinth Carrier insert to be fabricated at shop and installed after machining of all cracked, thin x-section of diaphragms. The design process was difficult taking about two weeks of development since the dimensions and attachment methods were limited. The new part shown below was designed to eliminate the weakness of OEM design, resist all forms of liquid erosion, and provide higher efficiency compared to original.
