Ethane 1800 KW Turbo-Expander Reliability Improvement: Vibration & DGS Seal Failures

By Abdulrahman Alkhowaiter 2017

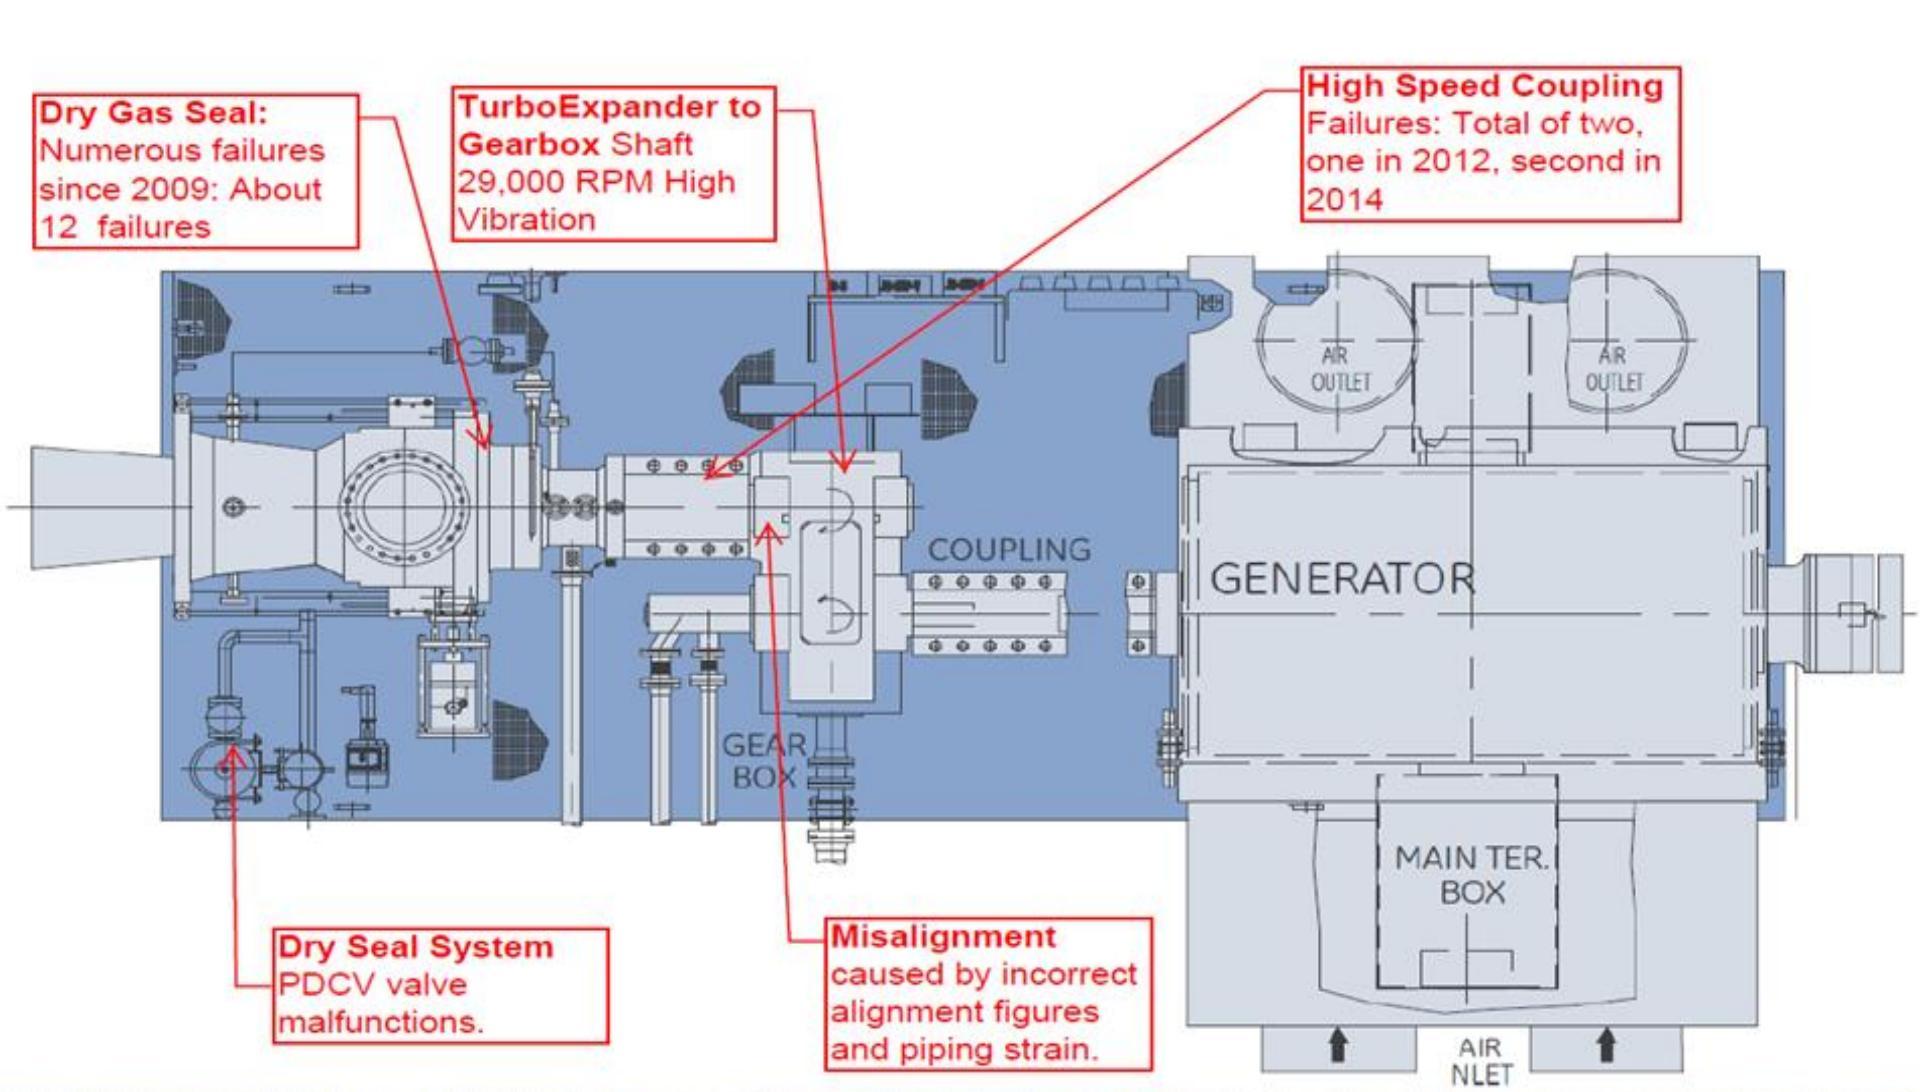
- Gearbox pinion high vibration of 1.25 to 2.0 mills on both expanders high speed gearbox pinion to expander shafts. Frequency was at 1X operating speed. No vibration problem on Expander shaft bearings. Alarm: 1.0 Mills, Shutdown 1.50 Mills.
- Twelve Dry Gas Seal face failures due to manufacturer design errors in the Seal Cartridge and Auxiliary DGS system.
- **Two High Speed Coupling Diaphragm Fatigue Failures.**

Mechanical Failure Locations

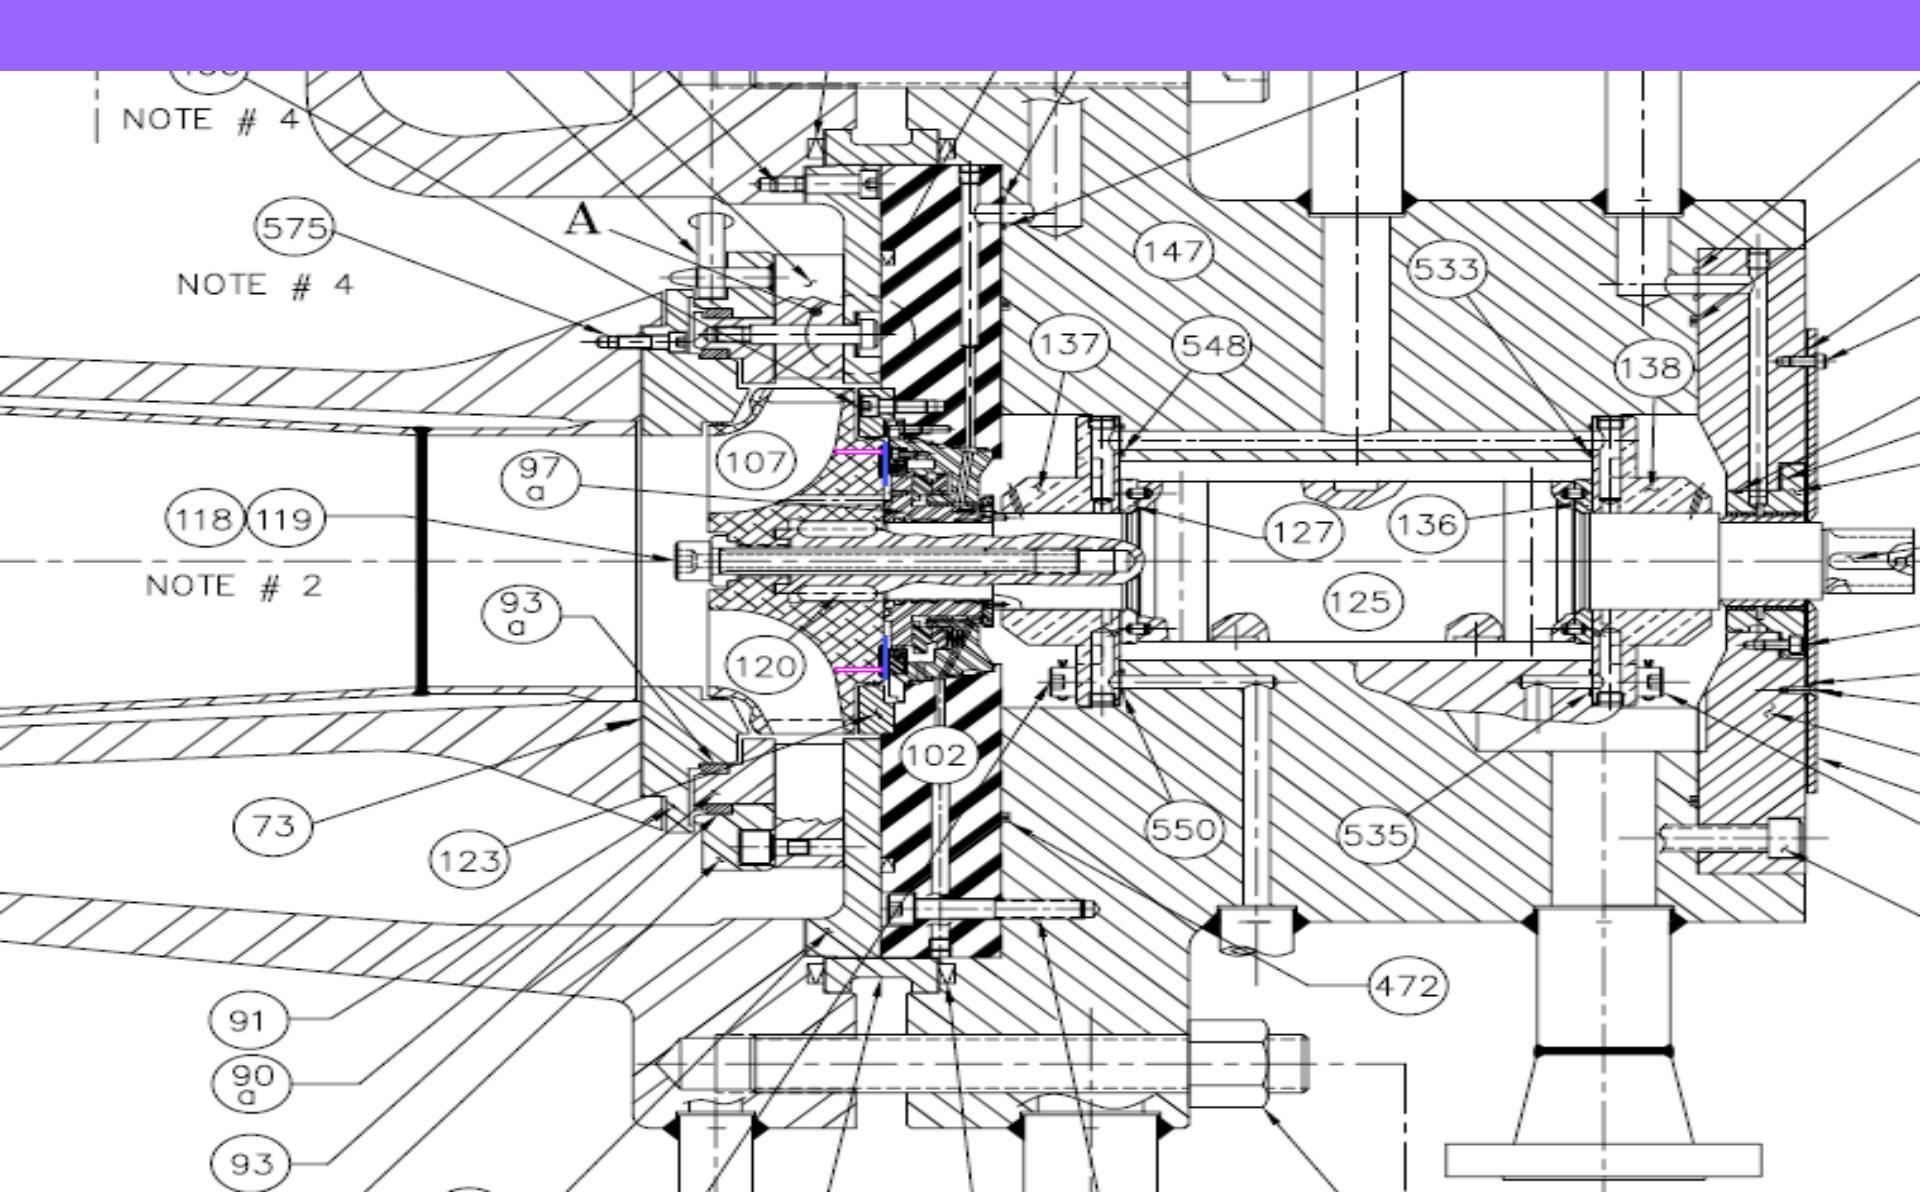
Drawing of Turboexpander: DGS Seal is Single Stage No Backup

Dry Gas Seal Failures: Design Solutions Which Resolved All Failures

- 1. The dry gas seal cartridge oil deflector was modified to make a new larger OD design that excludes oil entry compared to old design. In addition we pointed out a new flow path that was allowing oil entry to seal coming from bearing 45 degree angle holes. OEM agreed to plug bearing leakage holes and drill new ones away from DGS seal cavity.

- 2. The Turboexpander heat barrier wall was redesigned with additional larger holes for DGS seal inlet gas flow and leakage vents.
- 3. A new seal gas control valve PDCV from Masoneilan was proposed with correct CV rating only 5% of original failed PDCV valve for review and approval. We commented that this valve is superior to existing.

- 4. DGS Seal Gas Filters to be upgraded from existing 3.0 micron size down to 0.5 micron. We suggested using 1.0 micron and this was applied.
- 5. OEM recommended changing to volume flow control of Seal gas feed, instead of existing pressure differential control. We rejected this as pressure control is more robust system. Middle solution was pressure control but maintain volume flow for monitoring purposes only.

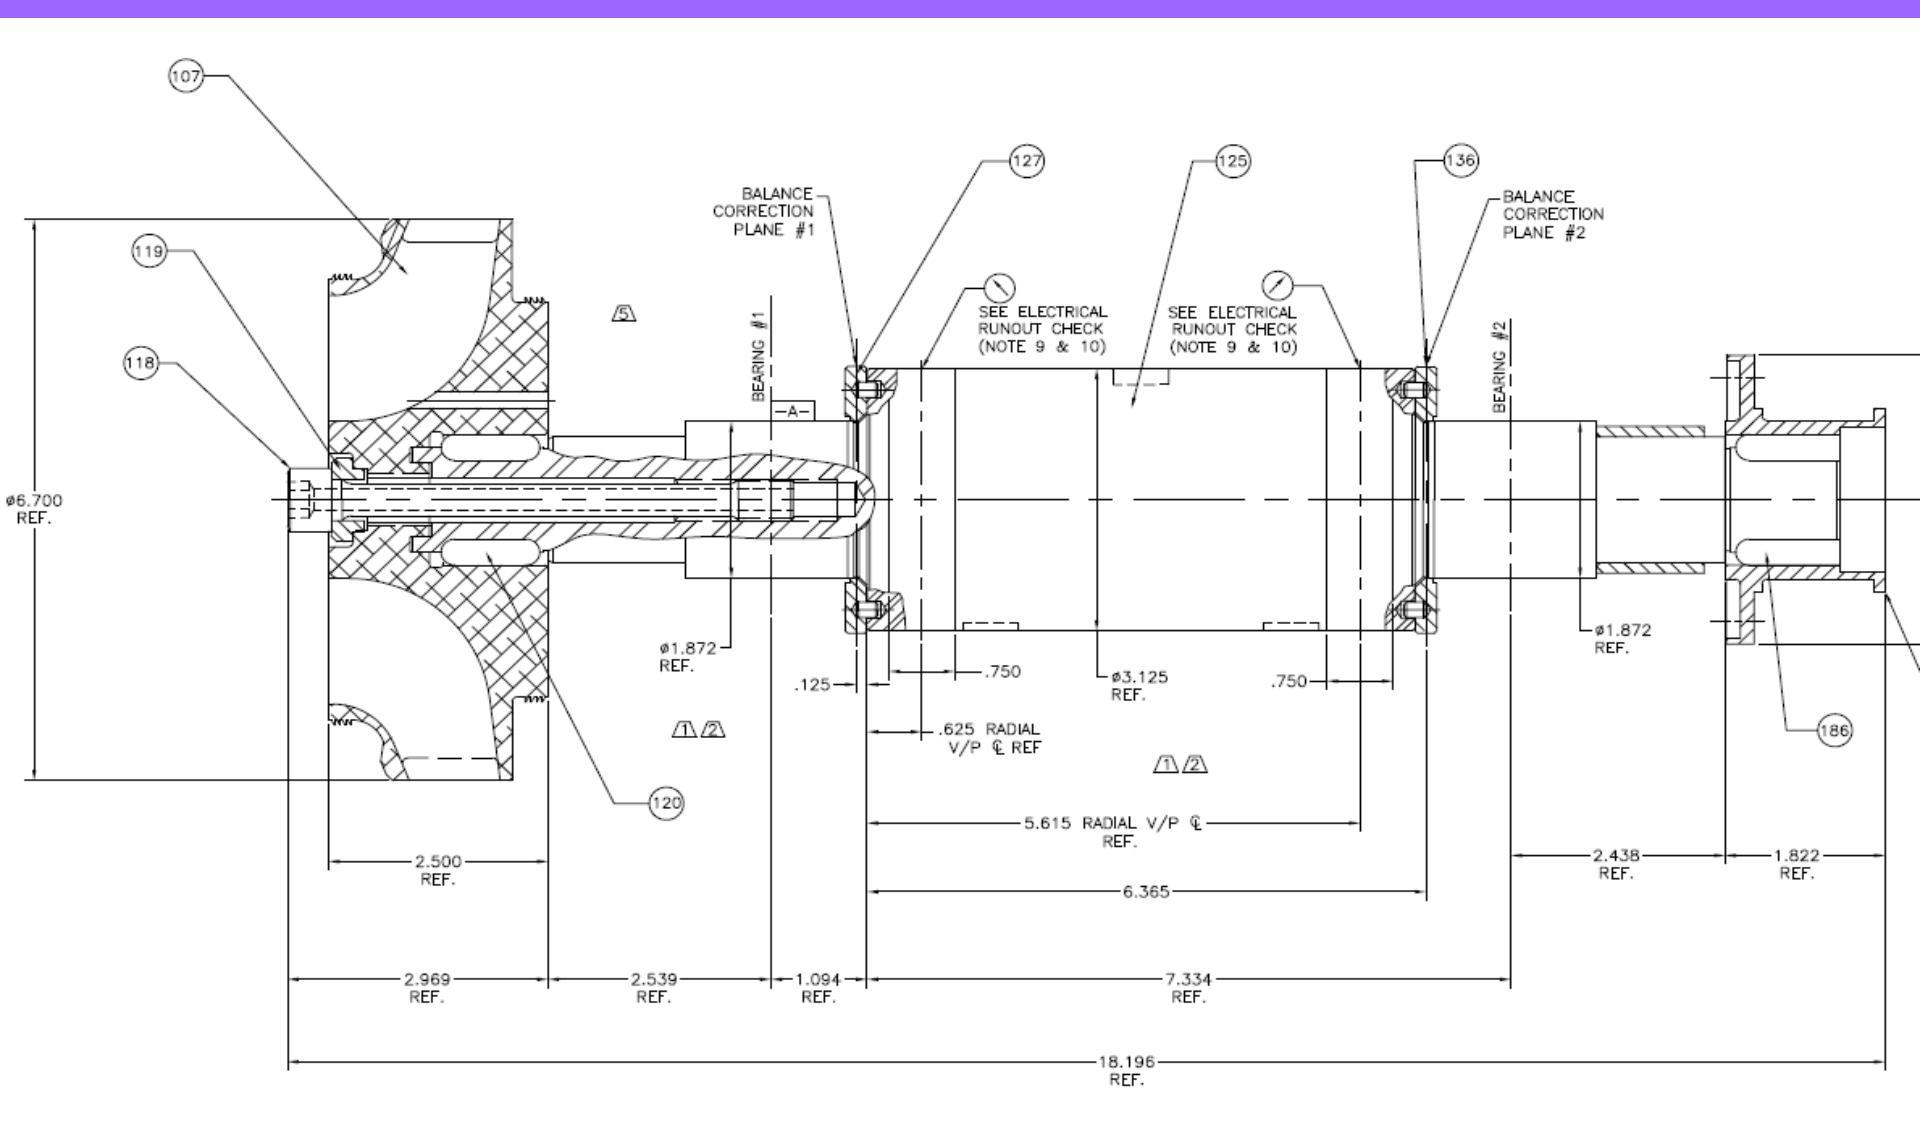
Expander Rotor 28,500 Rpm Large Diameter Bearings Max Vibration 0.30 Mills, Hydrostatic Bearings 400 Psig

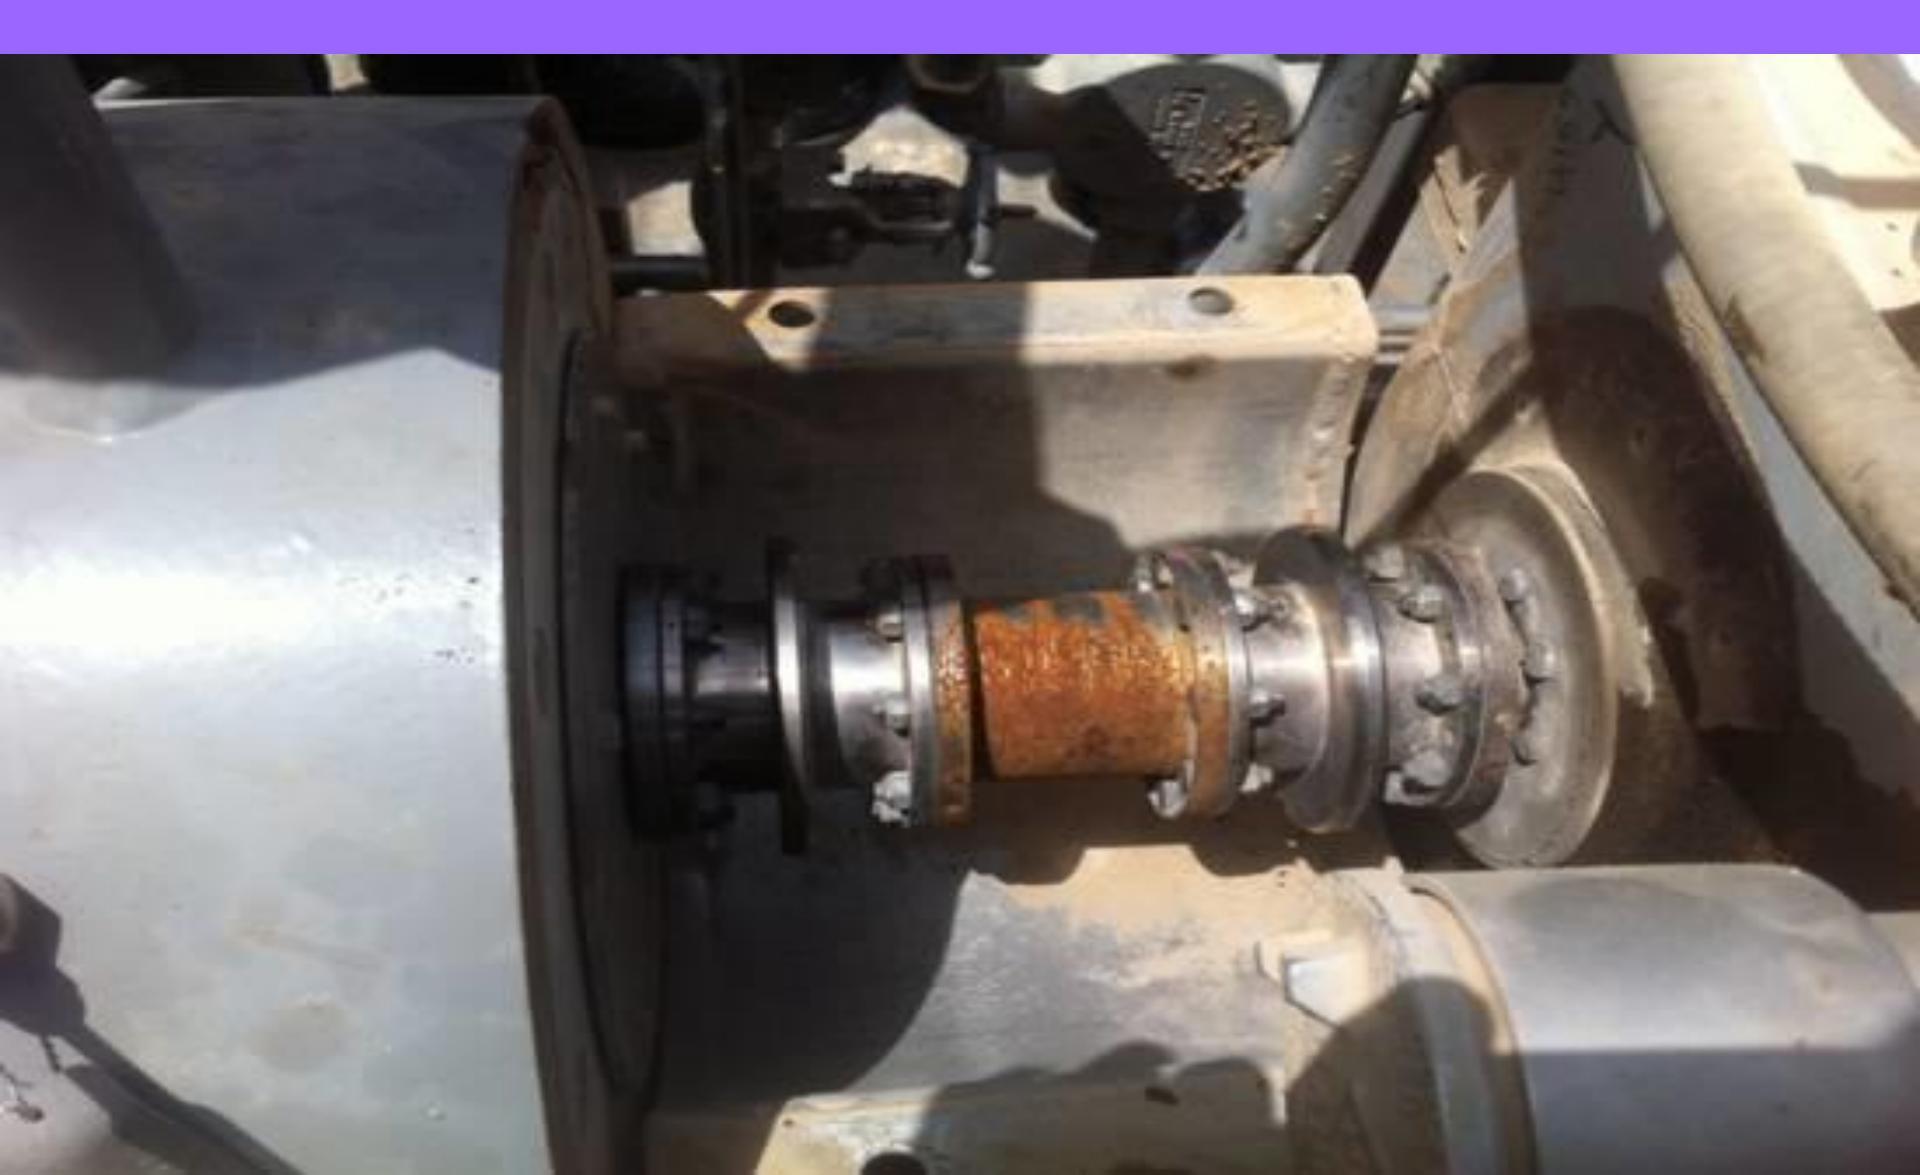
High Speed Coupling 28,500 RPM No Sealed Guard: Dust Unbalance-Corrosion

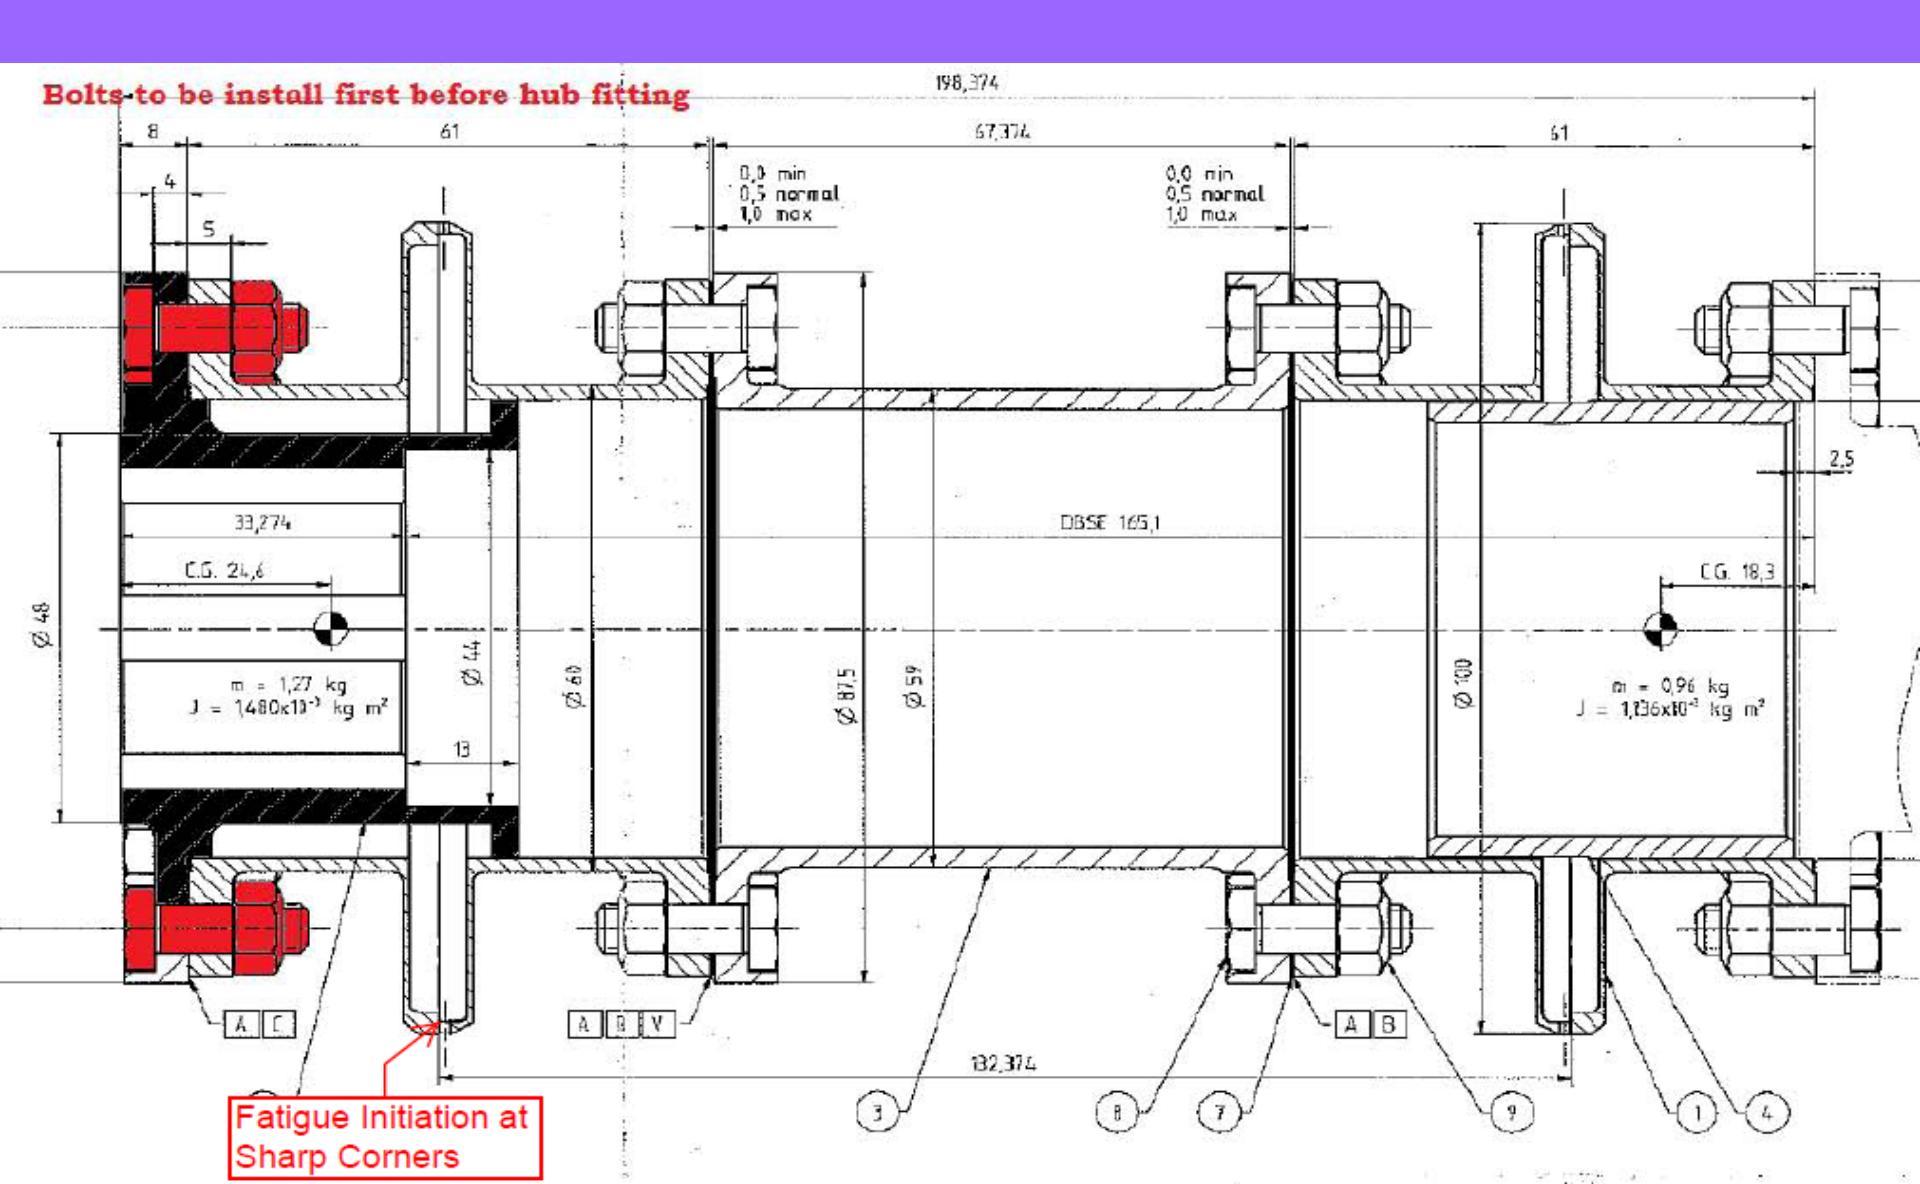
High Speed Coupling Failed Membranes Due to High Misalignment

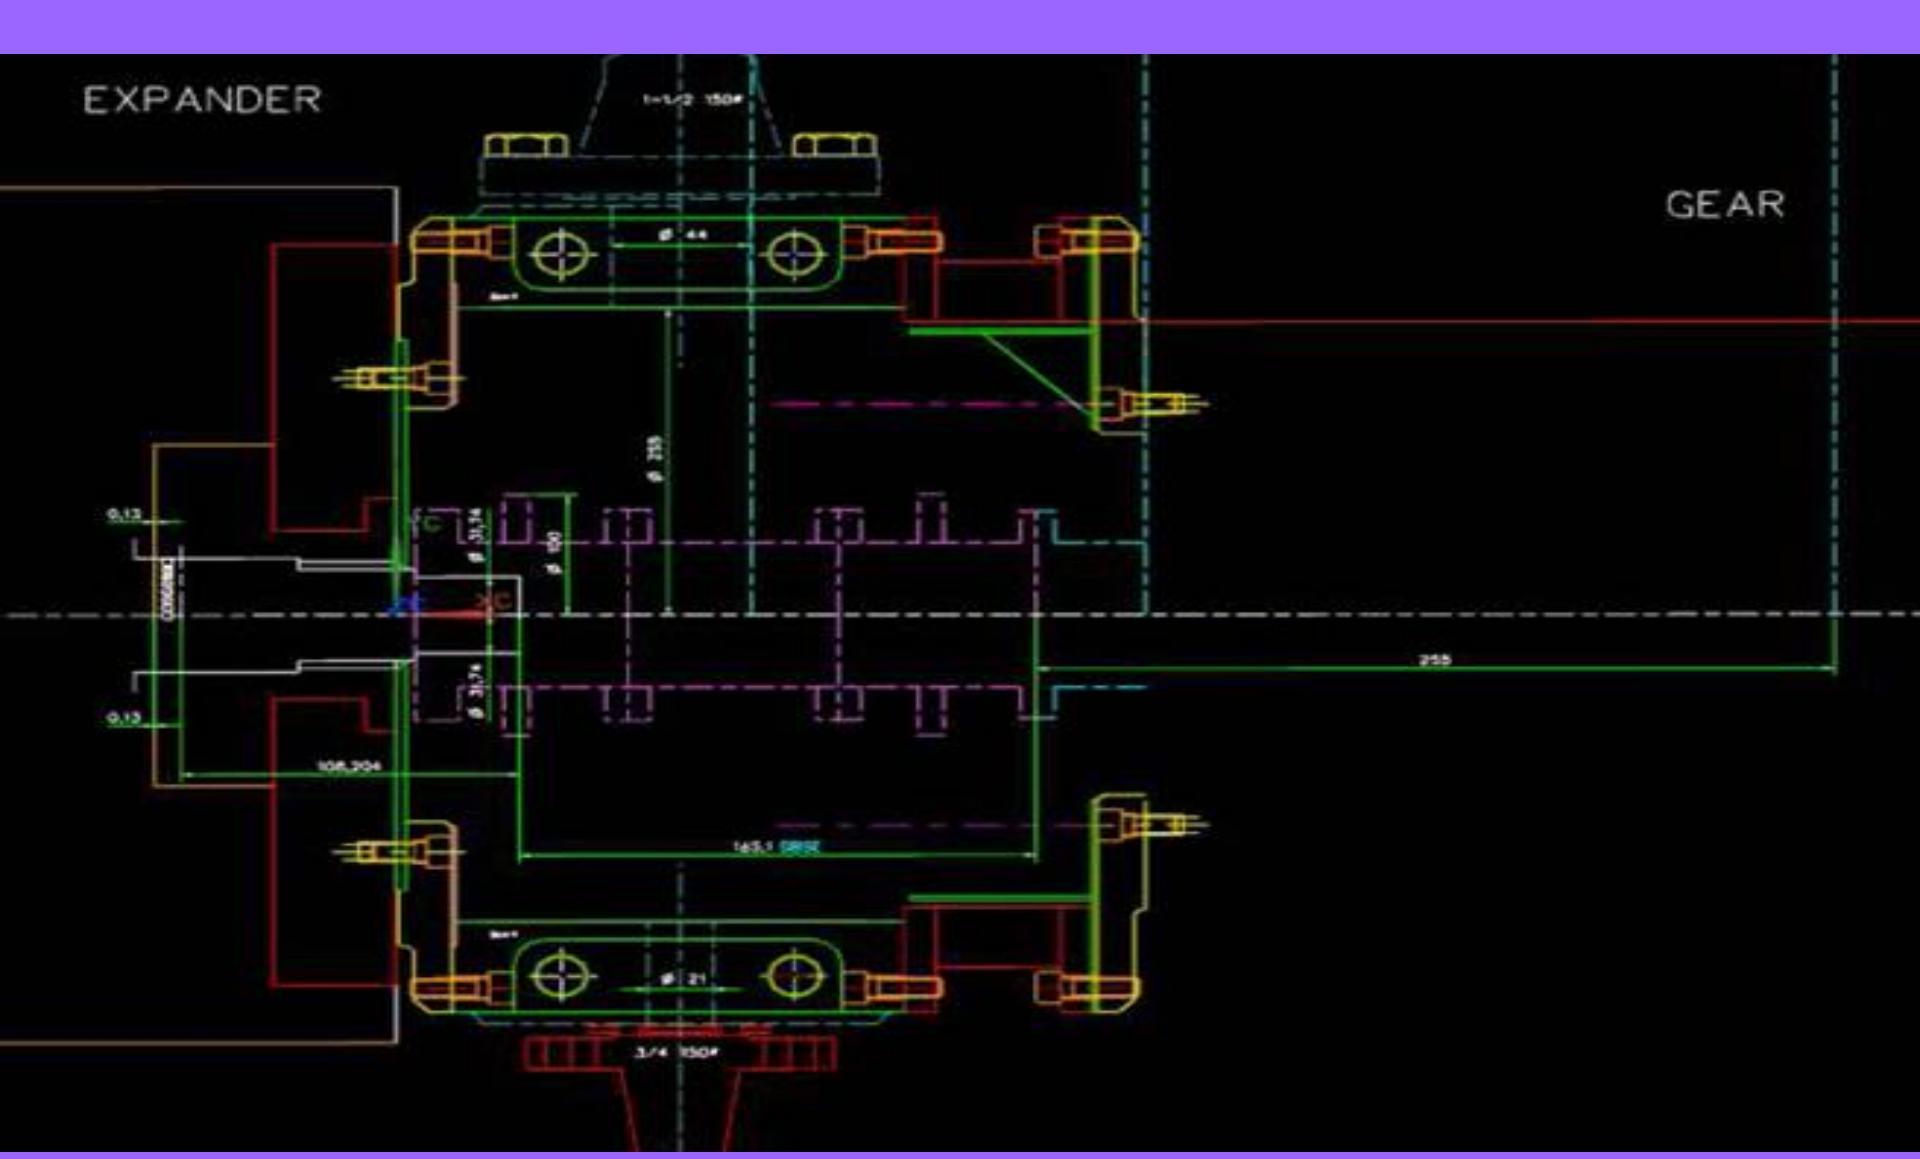
New High Speed Sealed Coupling Guard Designed By Manufacturer

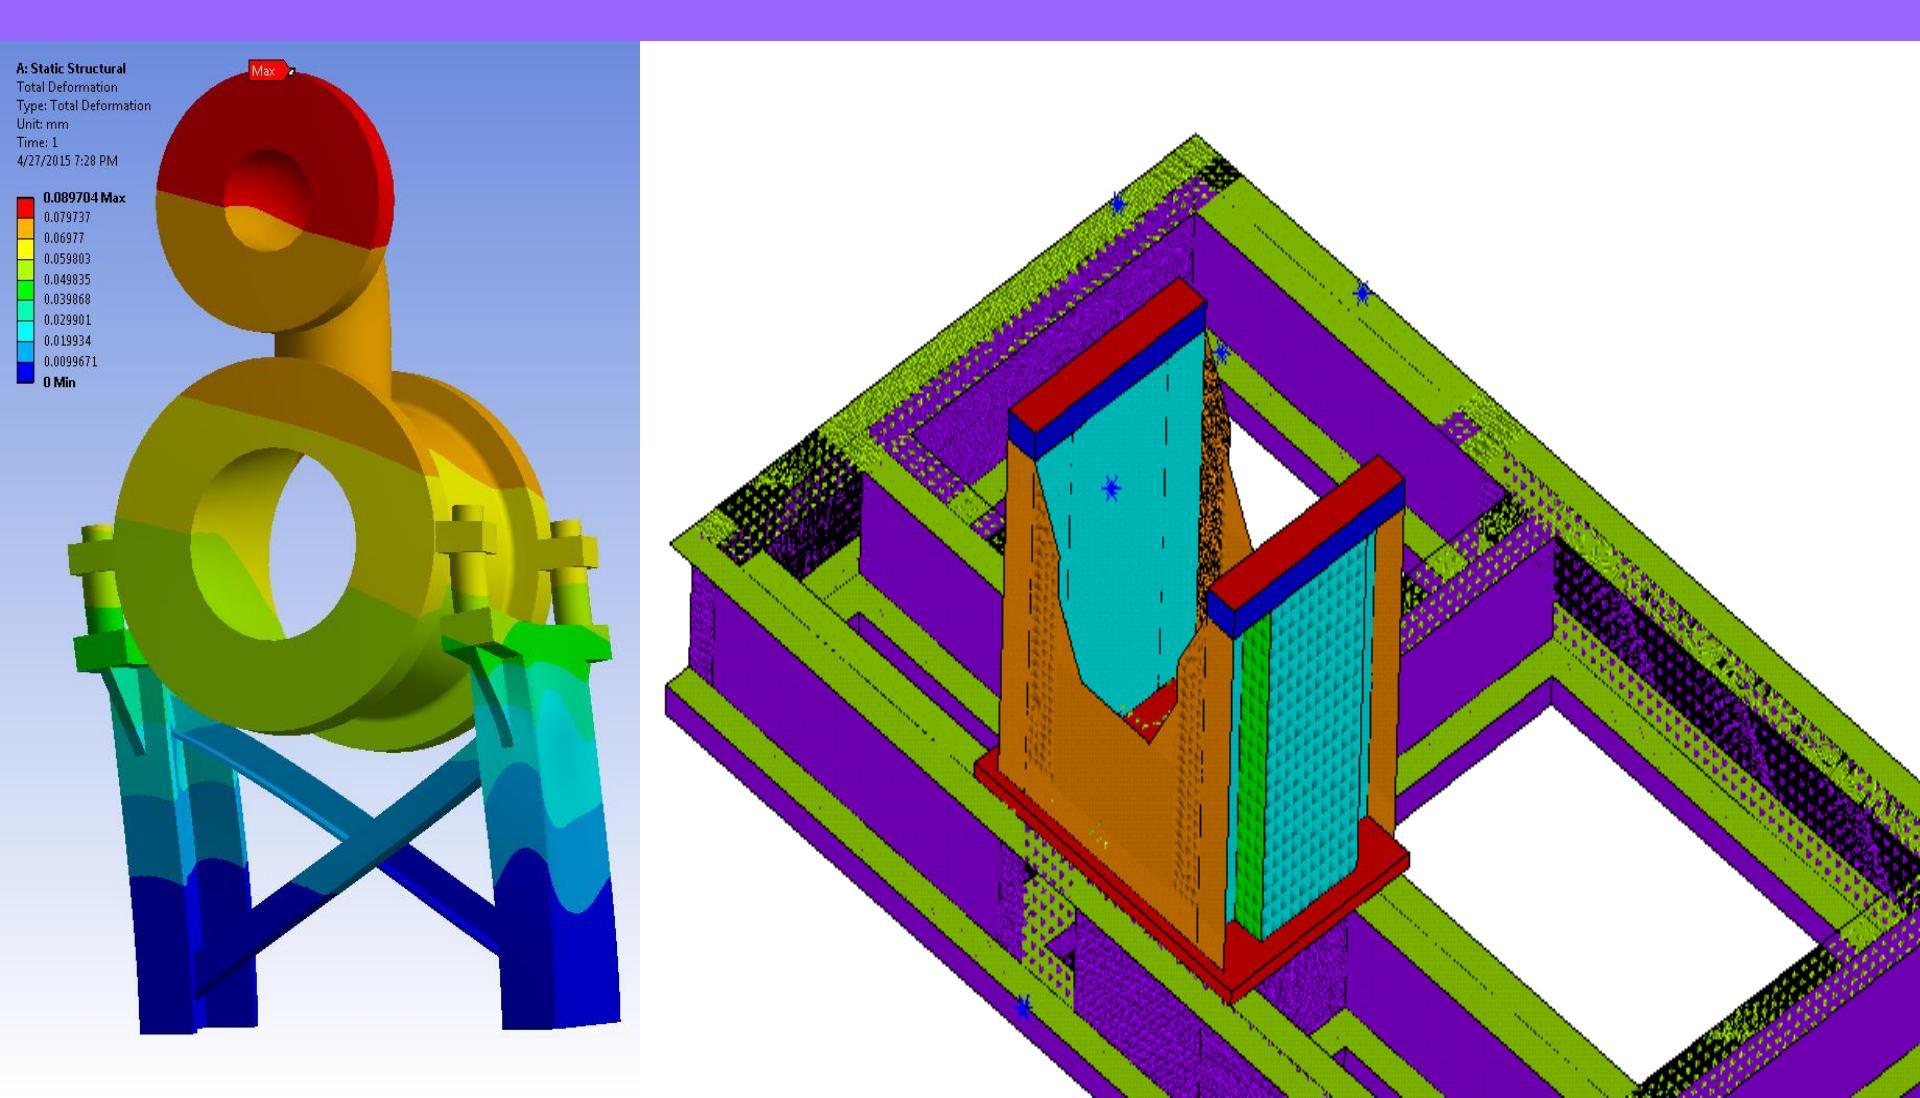
- 1. Turboexpander support footing on skid was studied and deemed too flexible with poor structural support to Turboexpander. OEM proposed a high strength and stiffness support cradle to be fabricated locally New support has 500% increase in stiffness compared to old. We had recommended this design with comment that new welded steel base plate thickness to be 25 mm minimum.
- 2. High Inlet-outlet Piping Strain was found due to poor LSTK design of piping. Piping engineers changed the design to reduce stress.
- 3. Turboexpander Coupling guard was redesigned to be a sealed coupling guard to exclude dirt and moisture. The coupling alignment figures were improved with hot Laser Alignment.
- 4. Shaft Coupling failures; OEM utilized the existing 28,500 RPM HS coupling. We recommended that they upgrade to better design couplings but OEM wanted fair trial of Existing Coupling.

Expander Has Excessive Deflections: Poor Support Design; New Support 5x Stiffness

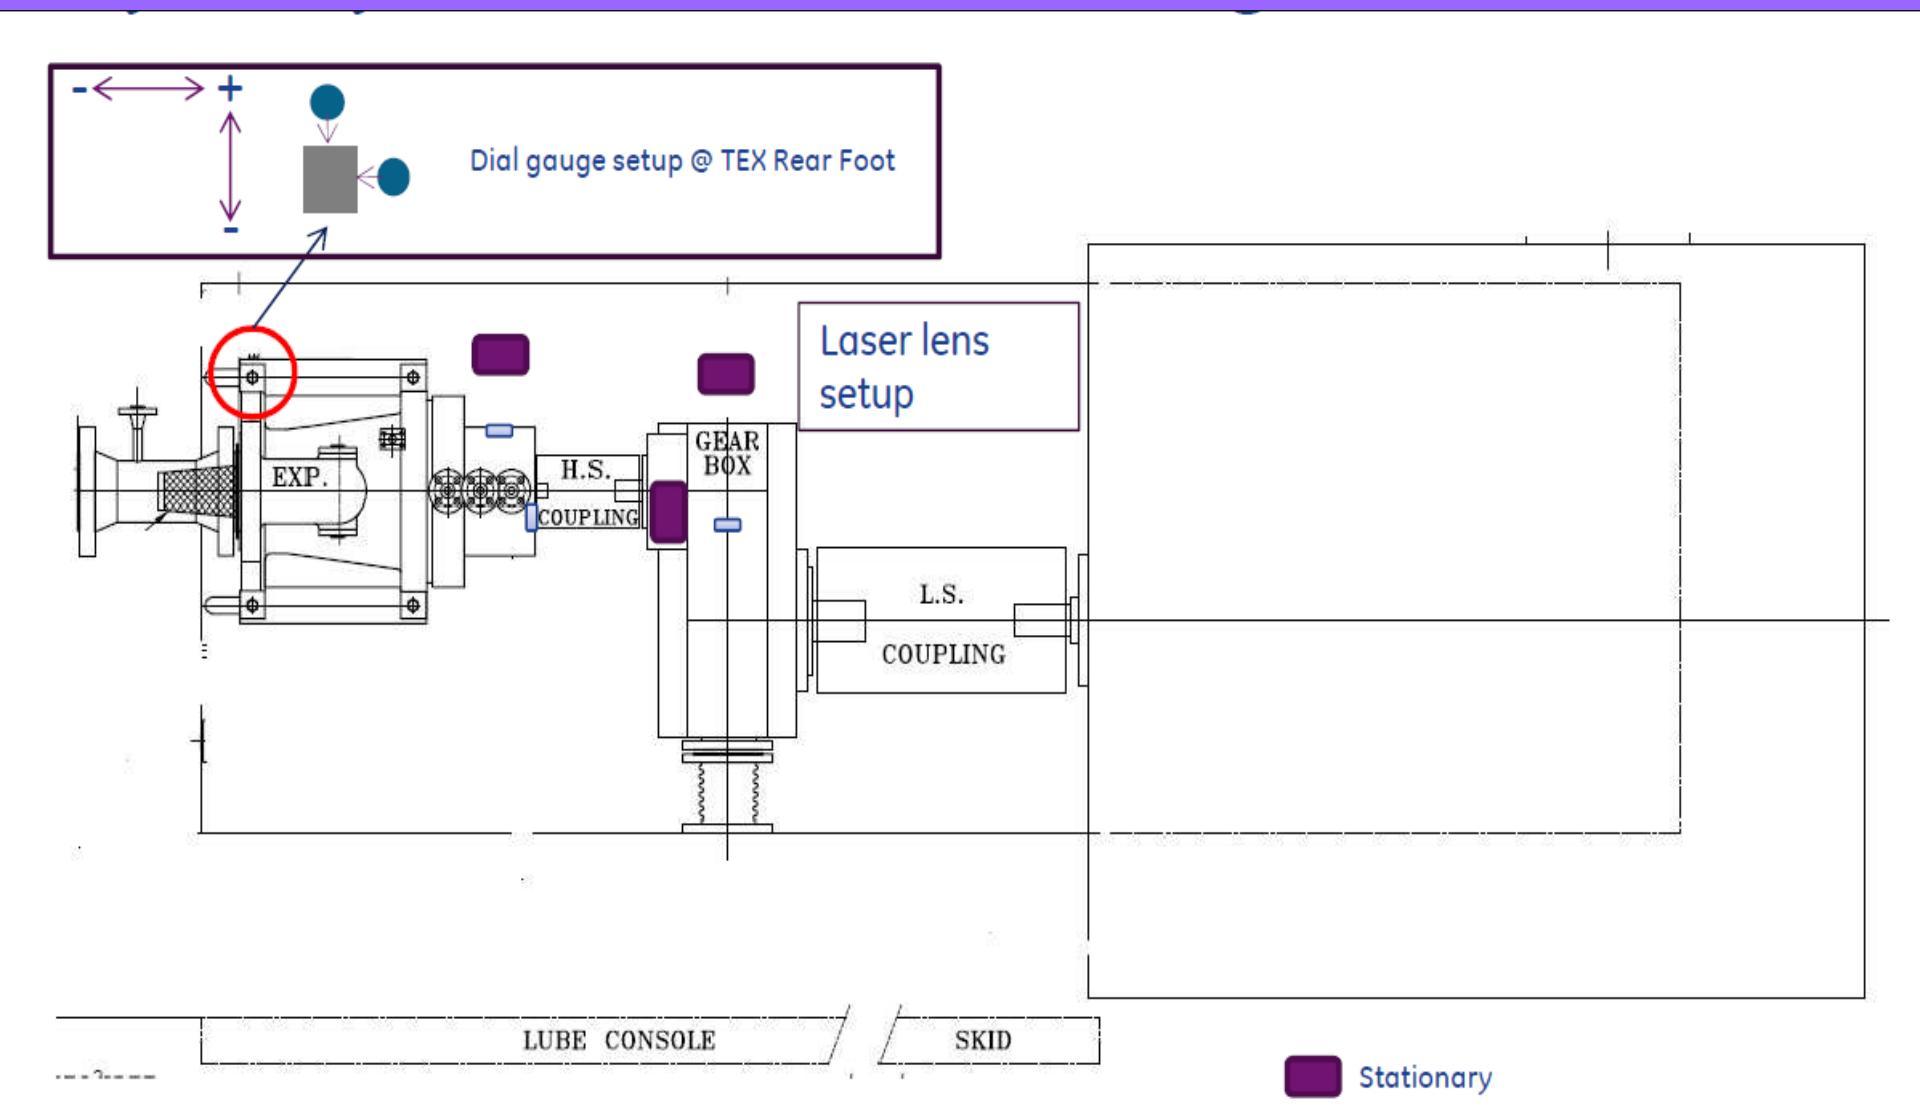
Highly Sensitive to Misalignment; We Requested to Perform Hot Laser Alignment

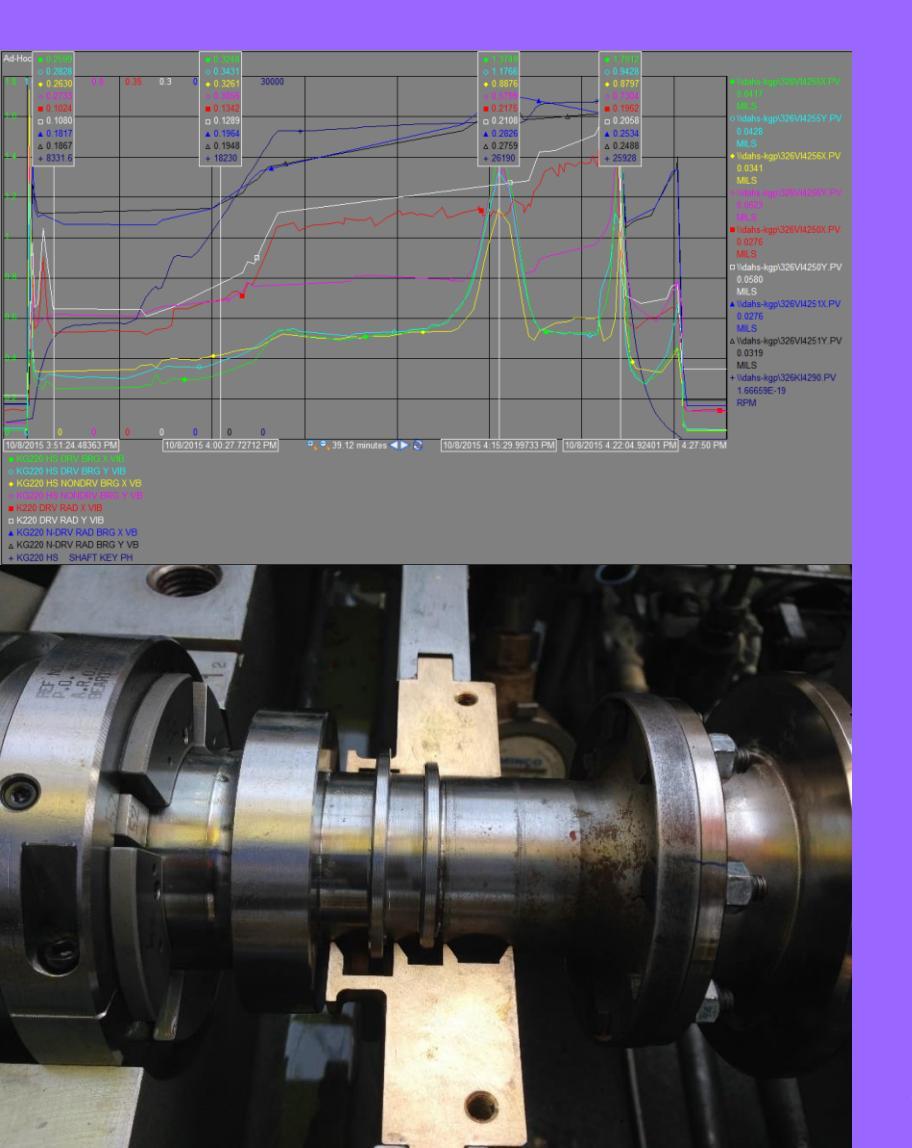
Bad News! After Design Modification: Vibration 1.70 Mills at Startup.....Back to Drawing Board

During startup on October 8, 2015, experienced Turboexpander HS pinion gearbox vibration 1.70 mills at 1 X and ¹/₂ X was experienced after loading at full speed. We initially focused on a rub indication at HS gear pinion shaft. In addition, the bearings did not show correct damping of vibration.

Findings of rubbing at oil seal labyrinth, and bearing high clearance to shaft. The gearbox manufacturer considered that the HS bearings at 28,500 rpm shaft speed were properly manufactured however we disagreed and installed shims inside bearings to *reduce clearances by 50%*.

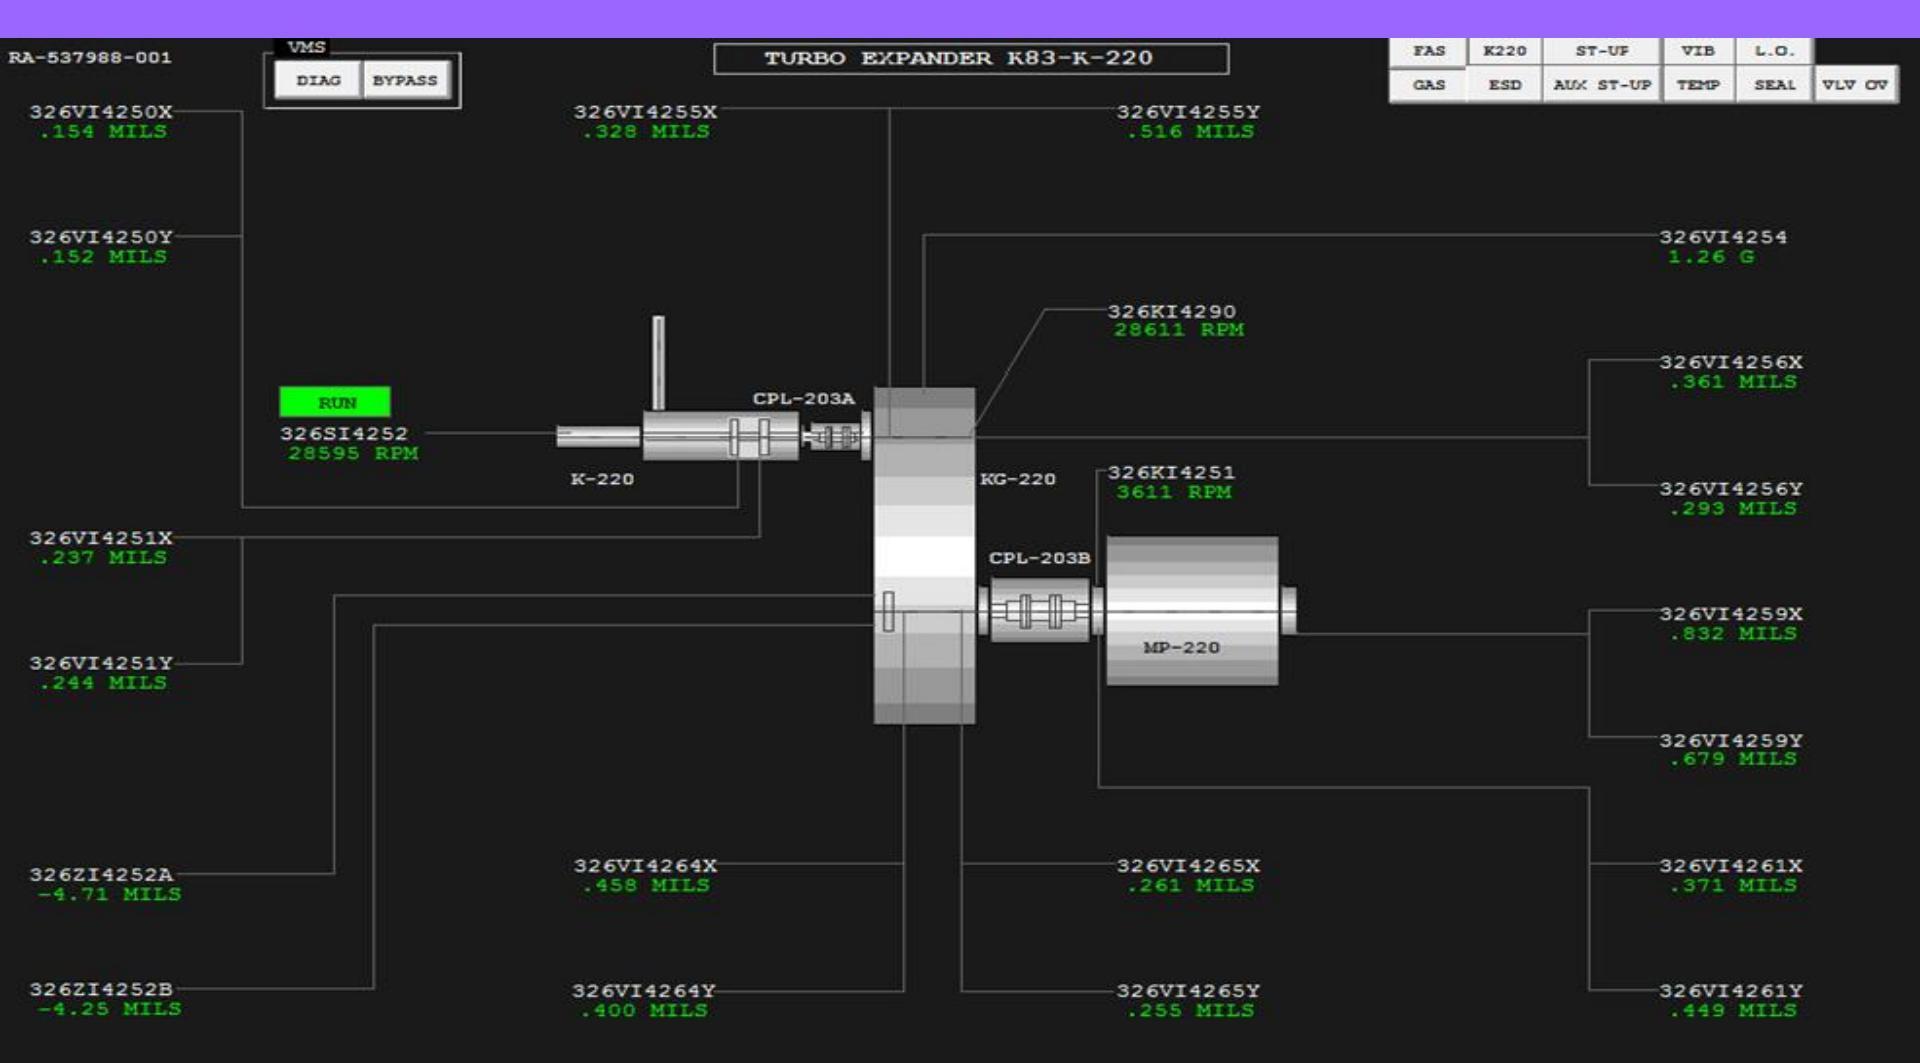
Both Turboexpanders have been functioning with excellent mechanical parameters in 2015 to 2020. In 4.5 years zero vibration problems; only one machine shutdown due to DGS failure. MTBF was 1.0 Month, now 4.5 years= 5400% Improvement

- 1. KGP Ethane Recovery Plant Turboexpander K-220 was started successfully on October 13, 2015 after major modifications. It met full Ethane recovery load of 1.75 MW electrical output, with all mechanical and process parameters smooth, only 0.53 Mills vibration HS. New deficiencies found were rubbing at HS pinion Laby due to OEM manufacturing, and gearbox incorrect bearing design clearances; these were reduced from 0.008 to 0.004 inch.

- 2. From the ten major design improvement ideas applied we developed nine of the ten design changes including new heavy duty support cradle under Turboexpander, new sealed HS coupling guard, new design dry gas seal cartridge, new dry gas seal auxiliary system components such as PDCV valve, improved piping supports, improved coupling alignment procedure, and new decompression shutdown valve. These improvements were completed in detail design by the manufacturer.
