Failure Analysis: Petrochemical Plant 185 KW Cooling Tower Fan Gearboxes Year 2010

By Abdulrahman Alkhwaiter

Introduction

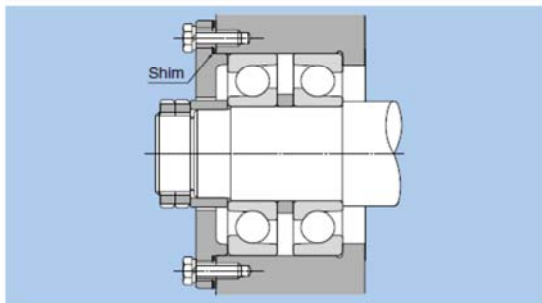
Fig. 15.14 Internal clearance adjustment using shims

2. **The LS shaft lower bearing on one unit was damaged** because the LS shaft bearing was excessively preloaded, leading to early fatigue failure of the bearing. This means that the thickness of the top shims was excessive. Solution: **The measured shaft float on this LS rotor should be 0.002 to maximum of 0.003 inch.** Use crane to lift LS shaft upwards, using dial indicator for measurement. This is to allow for axial differential thermal growth of casing and gear shafts in vertical direction. Our calculations have shown that the LS shaft [Length between bearings = 54 cm] grows axially on average about 0.002 to 0.003 inch greater than the gearbox, so this is an additional operating preload. Use lead wire crush test on top cover of all LS bearing housings to measure exact clearances during assembly, and install new shim thicknesses.

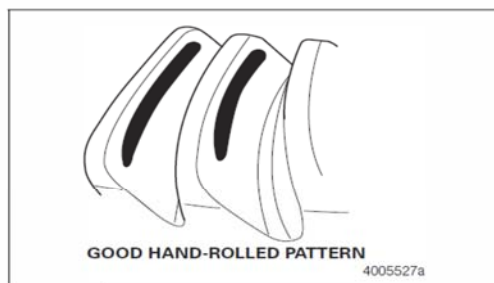
Figure 5.41

The location of good hand-rolled contact patterns for new gear sets is from the central toe, center, to the central heel area of the gear tooth and in the center between the top and bottom of the tooth. Figure 5.41.

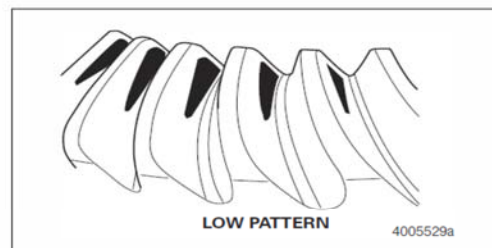
Figure 5.43

A high-contact pattern indicates that the drive pinion was not installed deep enough into the carrier. A low-contact pattern indicates that the drive pinion was installed too deep in the carrier.

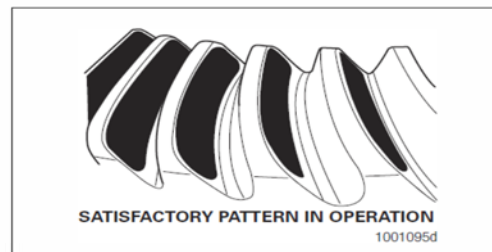
Figure 5.44

When the carrier is operated, a good hand-rolled pattern will extend approximately the full length of the gear tooth. The top of the pattern will be near the top of the gear tooth. Figure 5.44.
