High Vibration Failure: H2 Recycle 14,000 HP 9000 RPM Centrifugal Compressor Innovative Repair

By Abdulrahman Alkhowaiter

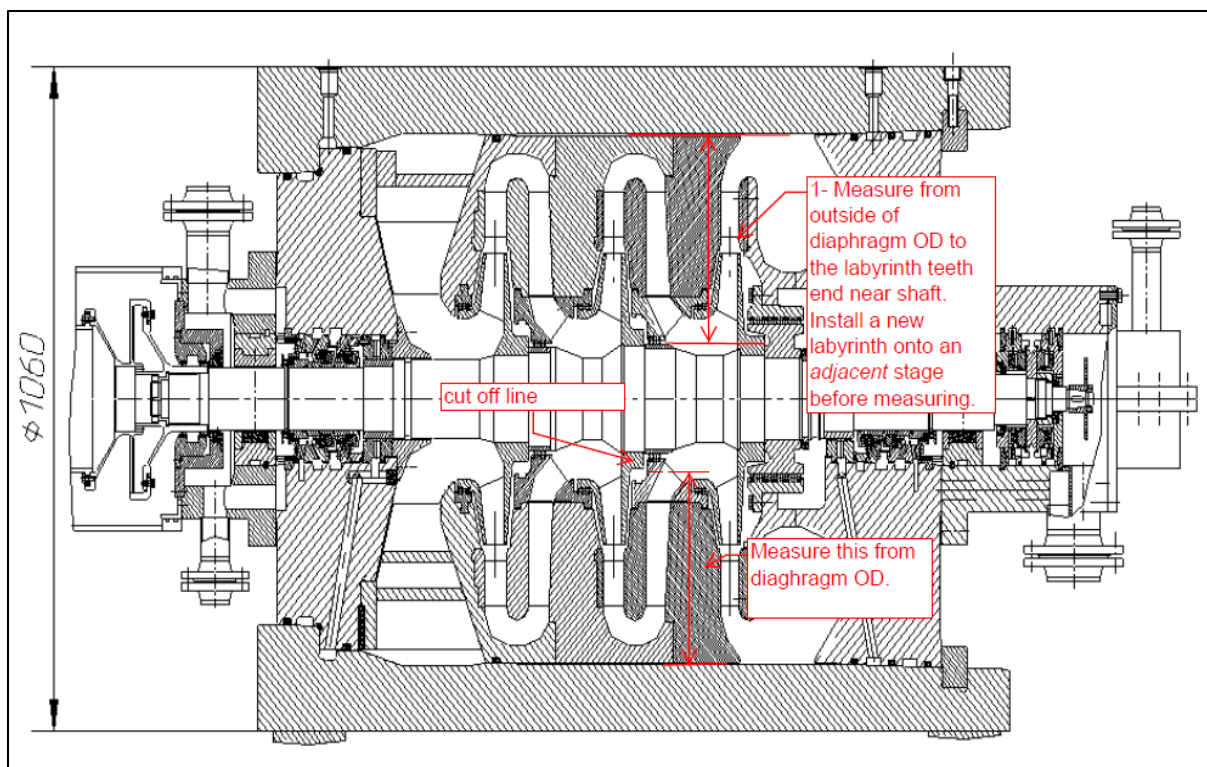
During overhaul at the repair shop the compressor cast iron diaphragm labyrinths were found to have severe damage due to liquid erosion and cracks from high turbulence vibration. No spare bundle was available. The failed components were non-weldable; this meant that the refinery must wait 3 months for new castings with USD 2.00 Million per day.

An innovation repair was proposed: New Labyrinth Carrier insert to be fabricated at shop and installed after machining of all cracked, thin x-section of diaphragms. The design process was difficult taking about two weeks of development since the dimensions and attachment methods were limited. The new part shown below was designed to eliminate the weakness of OEM design, resist all forms of liquid erosion, and provide higher efficiency compared to original.
